THE COLLEGE OF WILLIAM AND MARY

Zable Stadium Feasibility Study

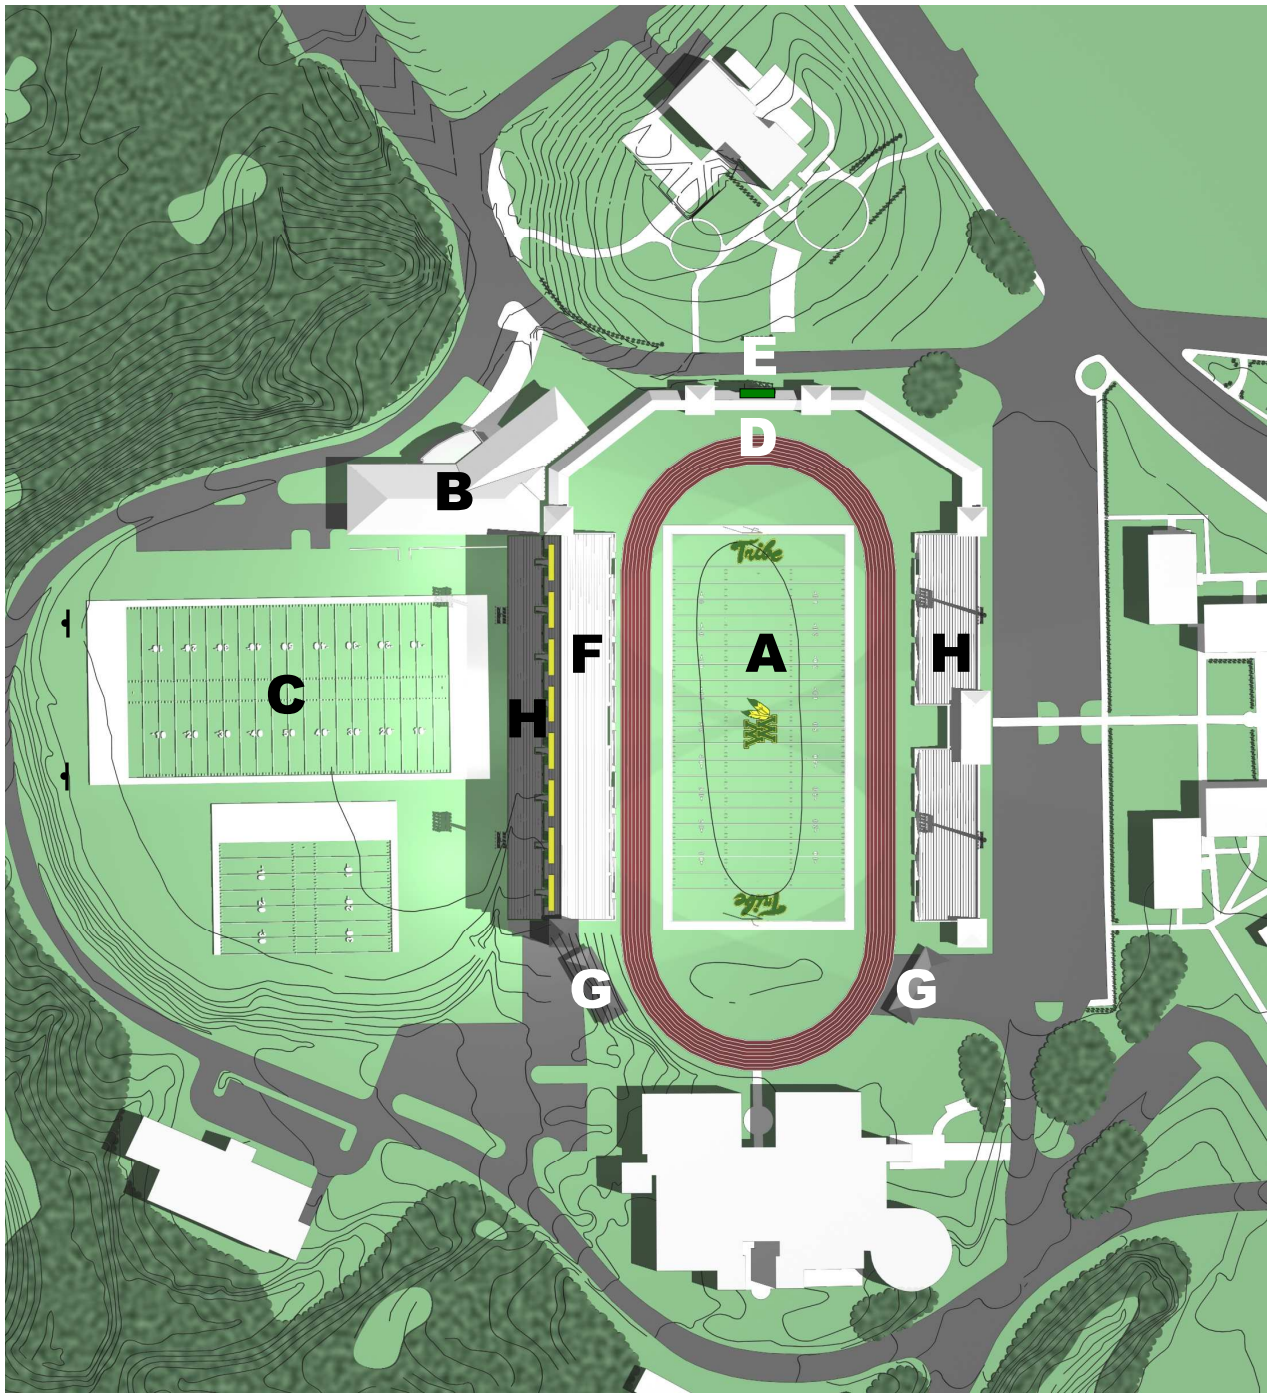
**FEASIBILITY PLAN DIAGRAM
III**

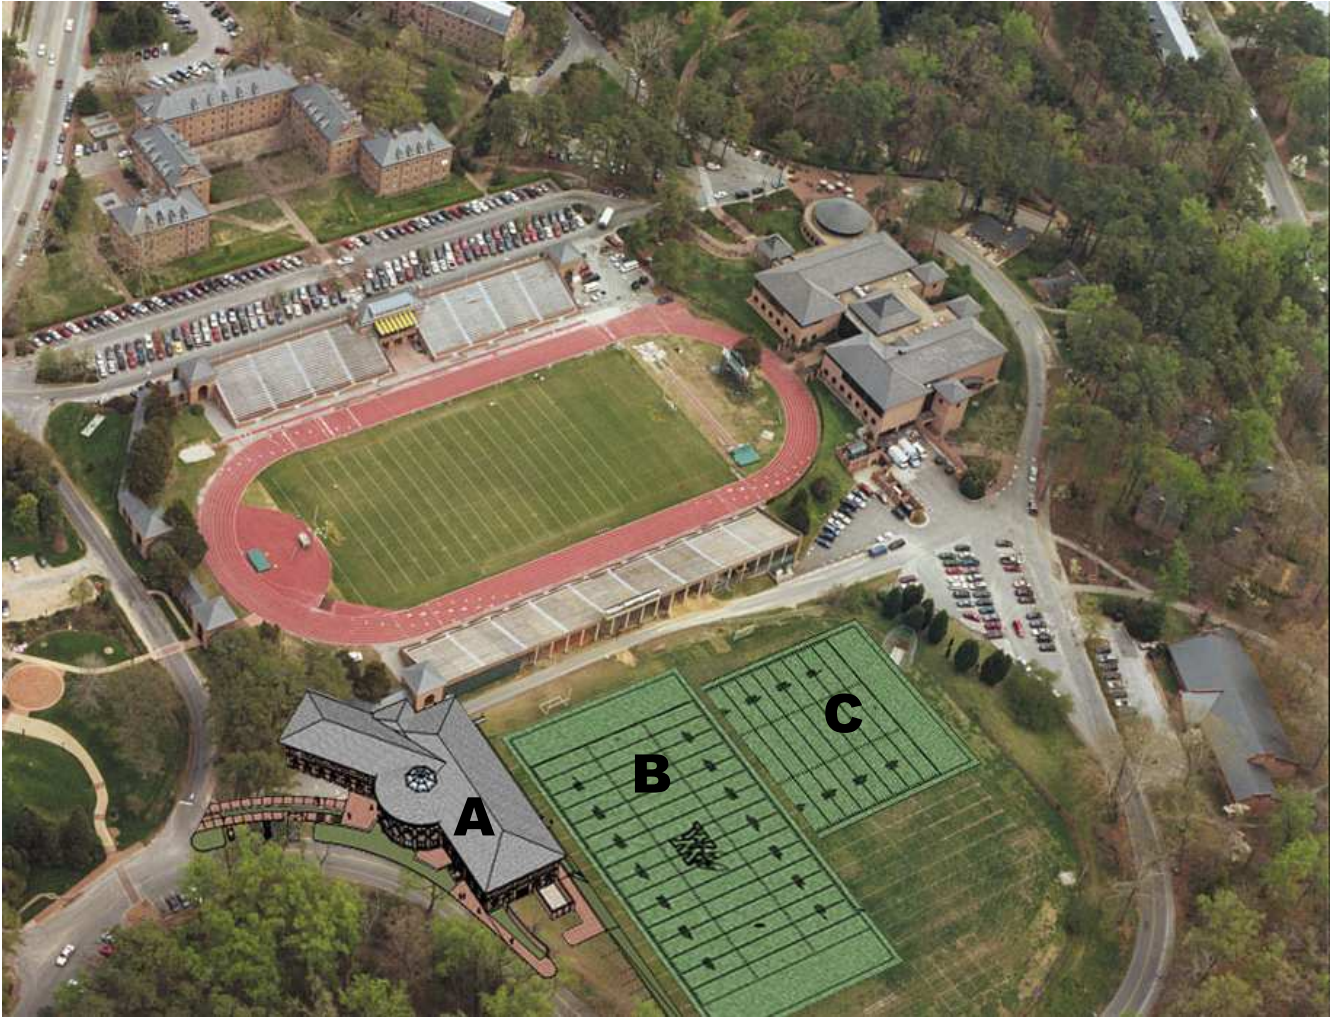
The existing practice fields to the west of Zable Stadium will be regraded for drainage and installation of an irrigation system. The area will accommodate a full-length football field in the east-west orientation and a half-field in the north-south orientation. The fields are placed as close to the training facility as possible for the convenience of the players and coaches. A well-fed irrigation system will be included with a layout to allow the field orientation to change to accommodate wear patterns.

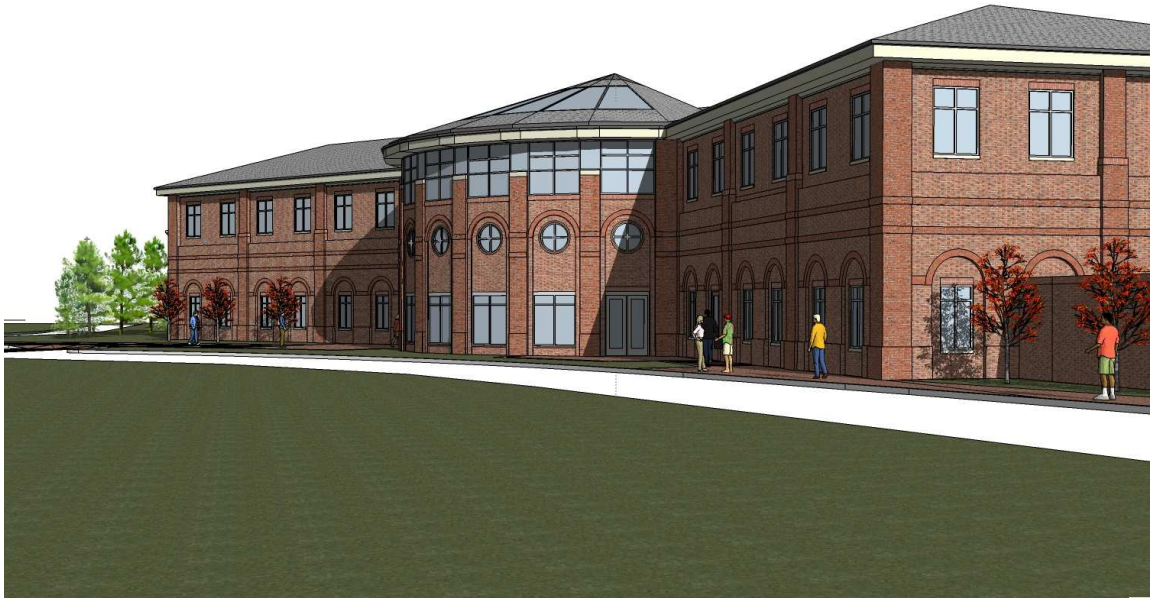
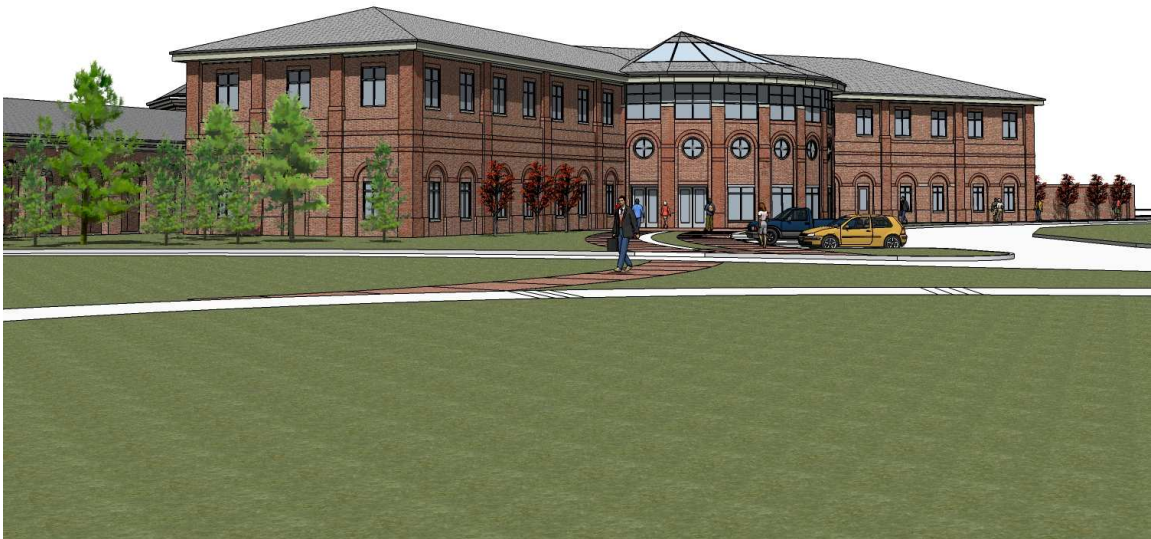
Jimmie Laycock Football Center
Renderings

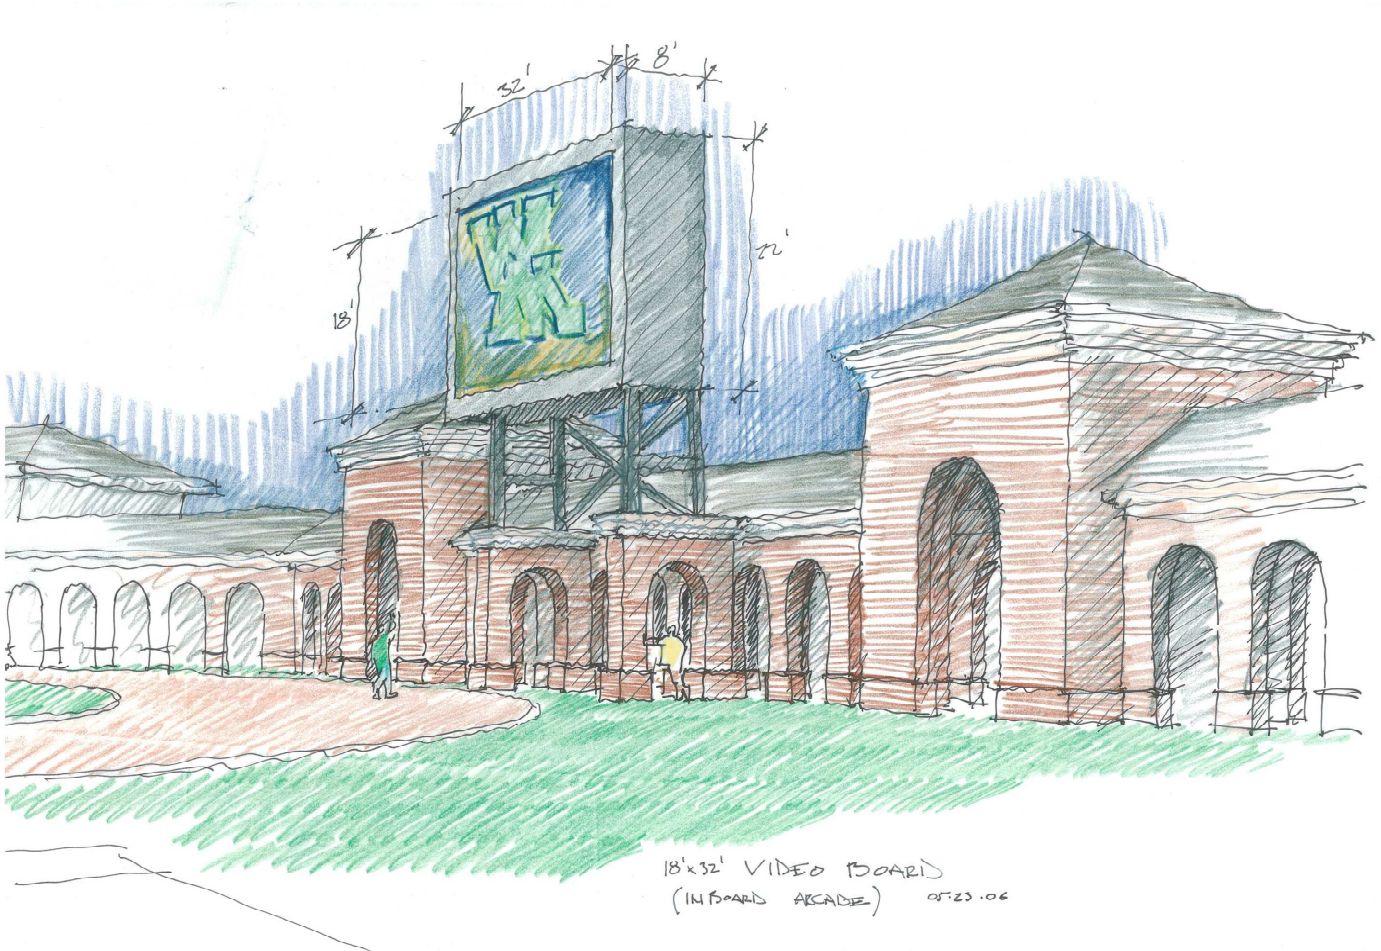
Zable Stadium Proposed Scoreboard

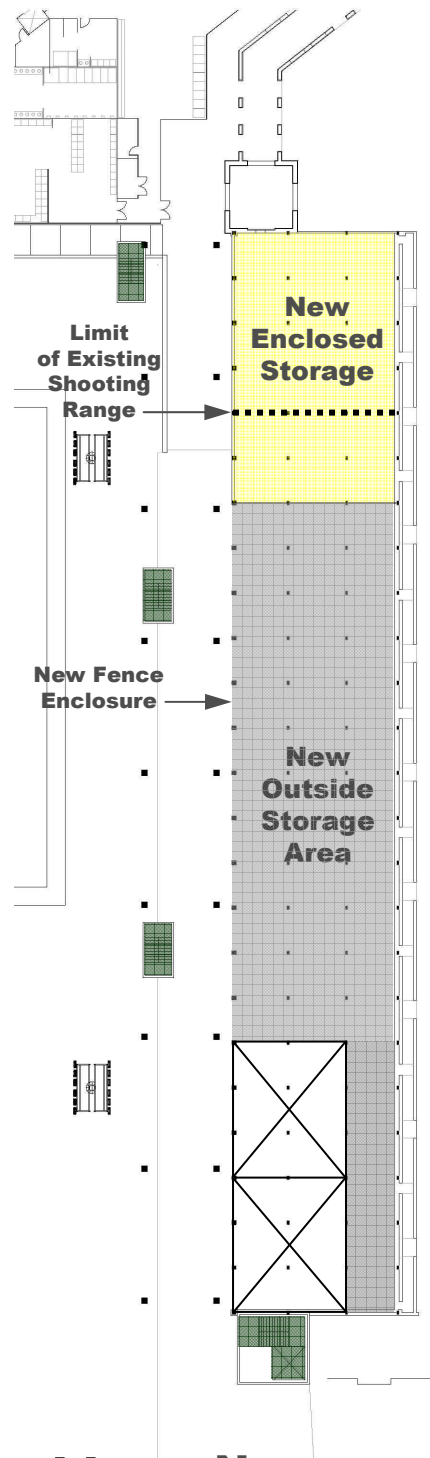
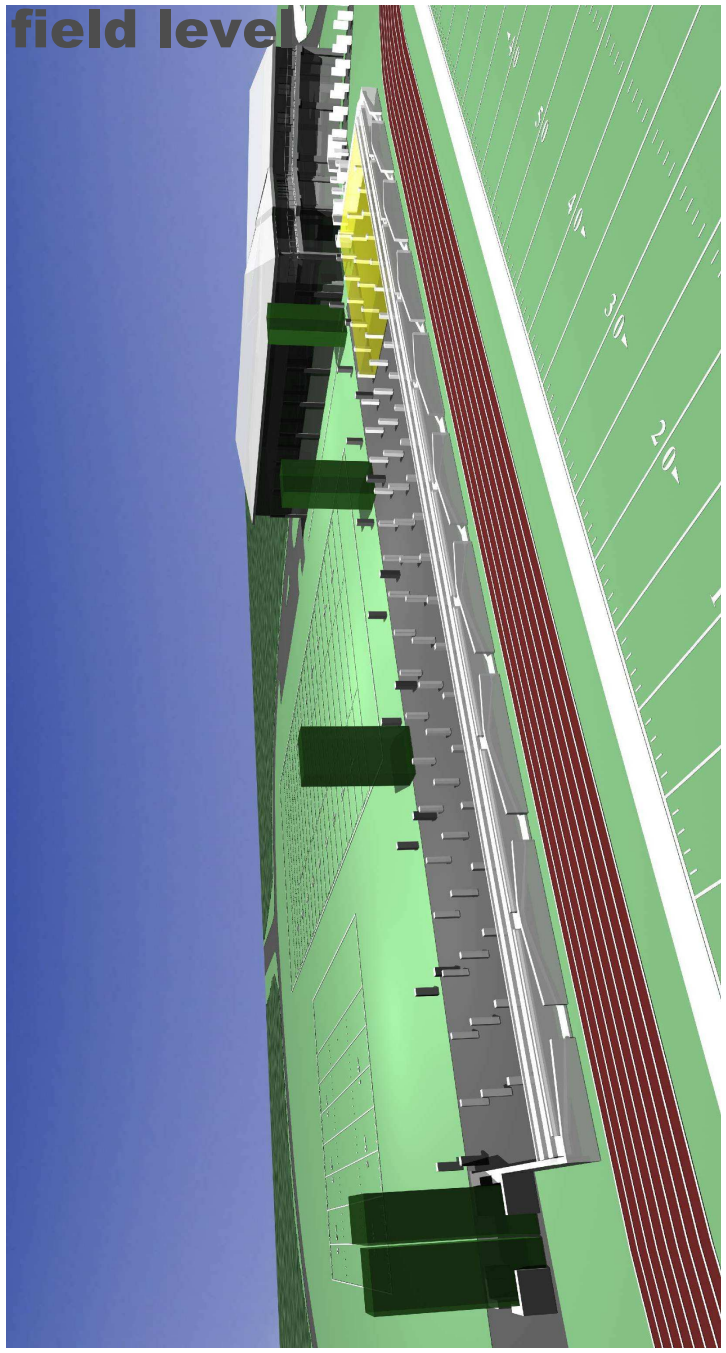
Option 1 – Replacement Including Suites
 field level

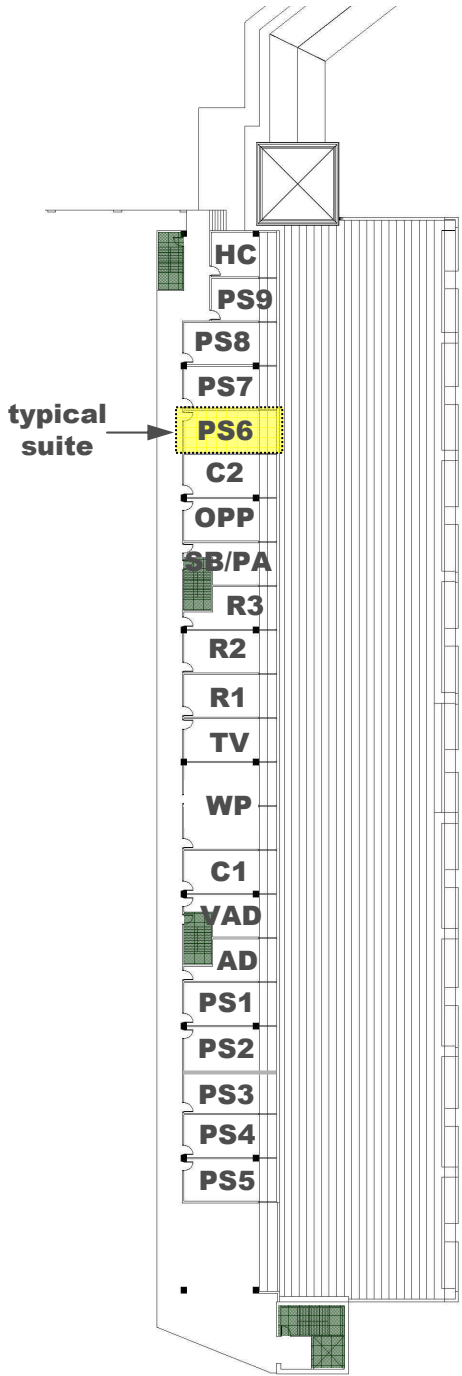
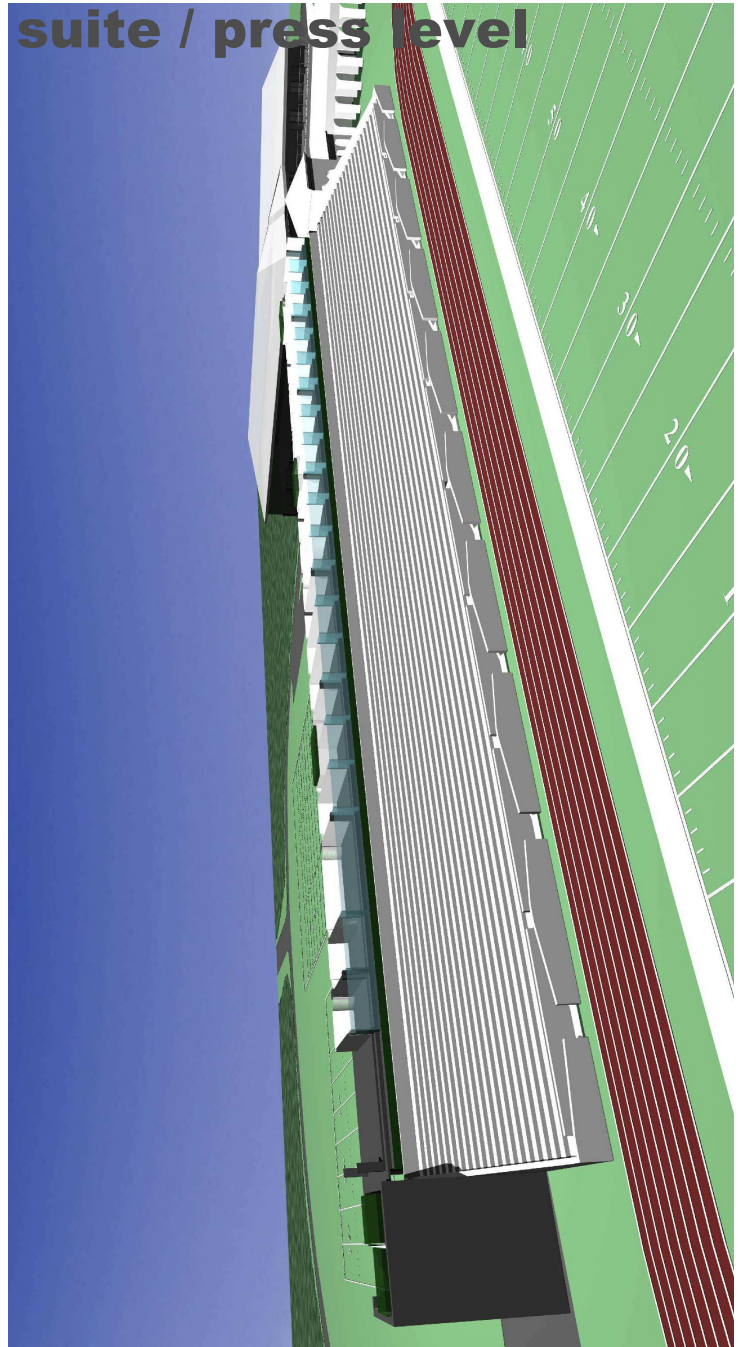
Option 1 – Replacement Including Suites
suite / press level

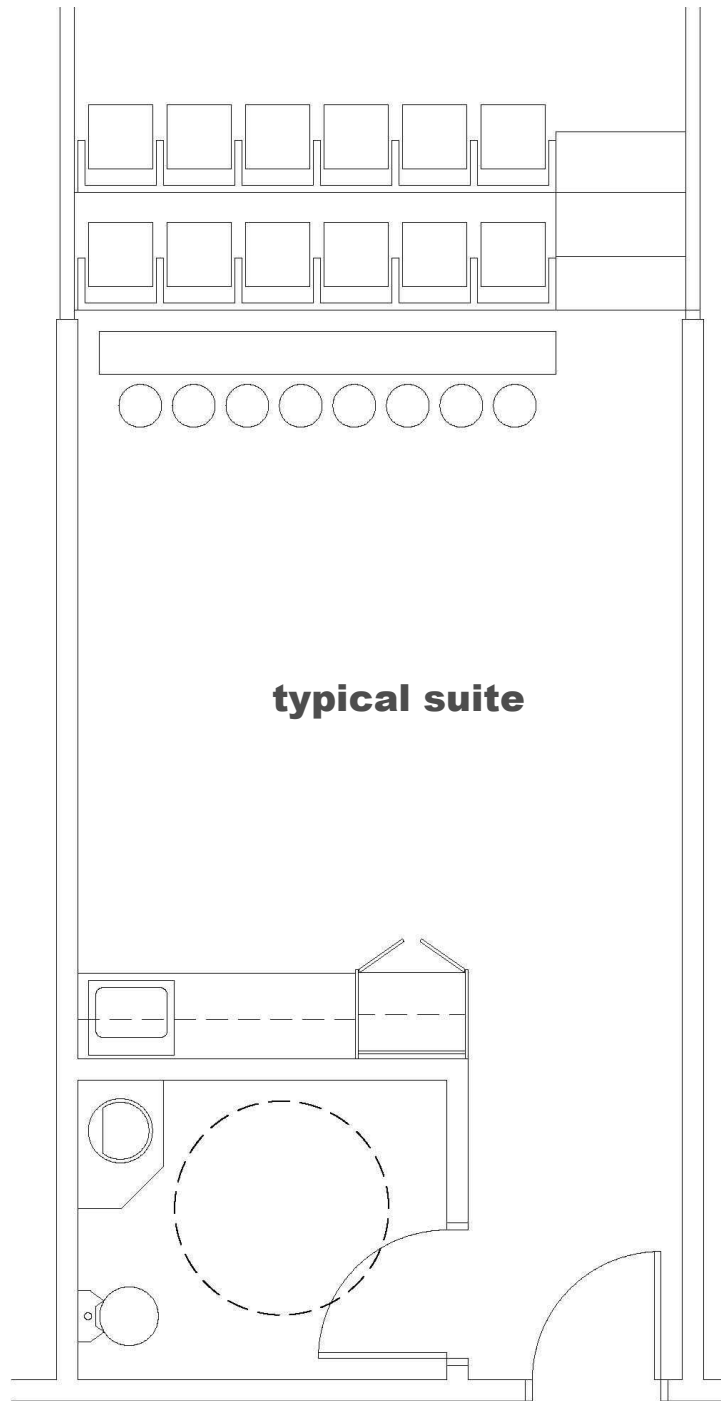
Option 1 – Replacement Including Suites
 typical suite layout

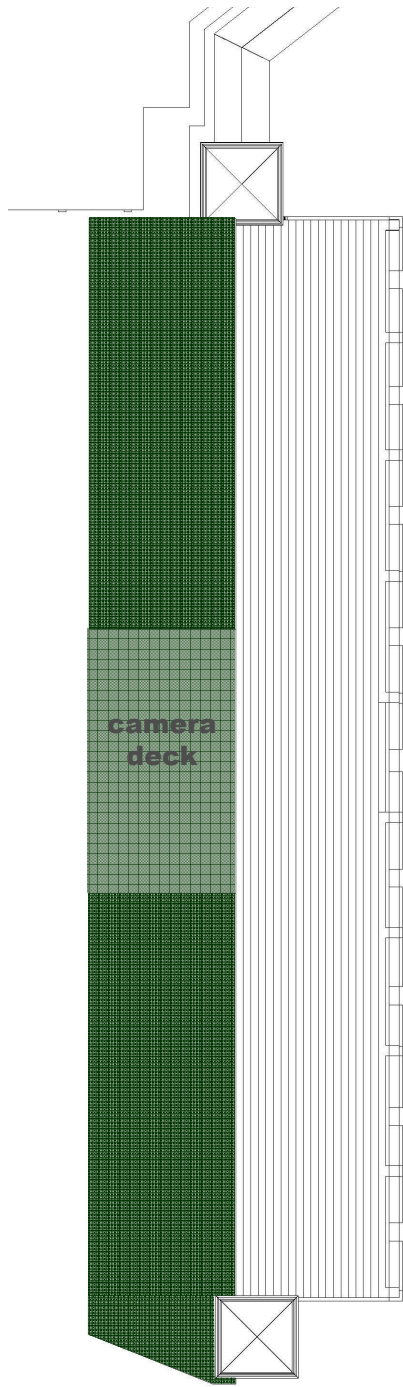
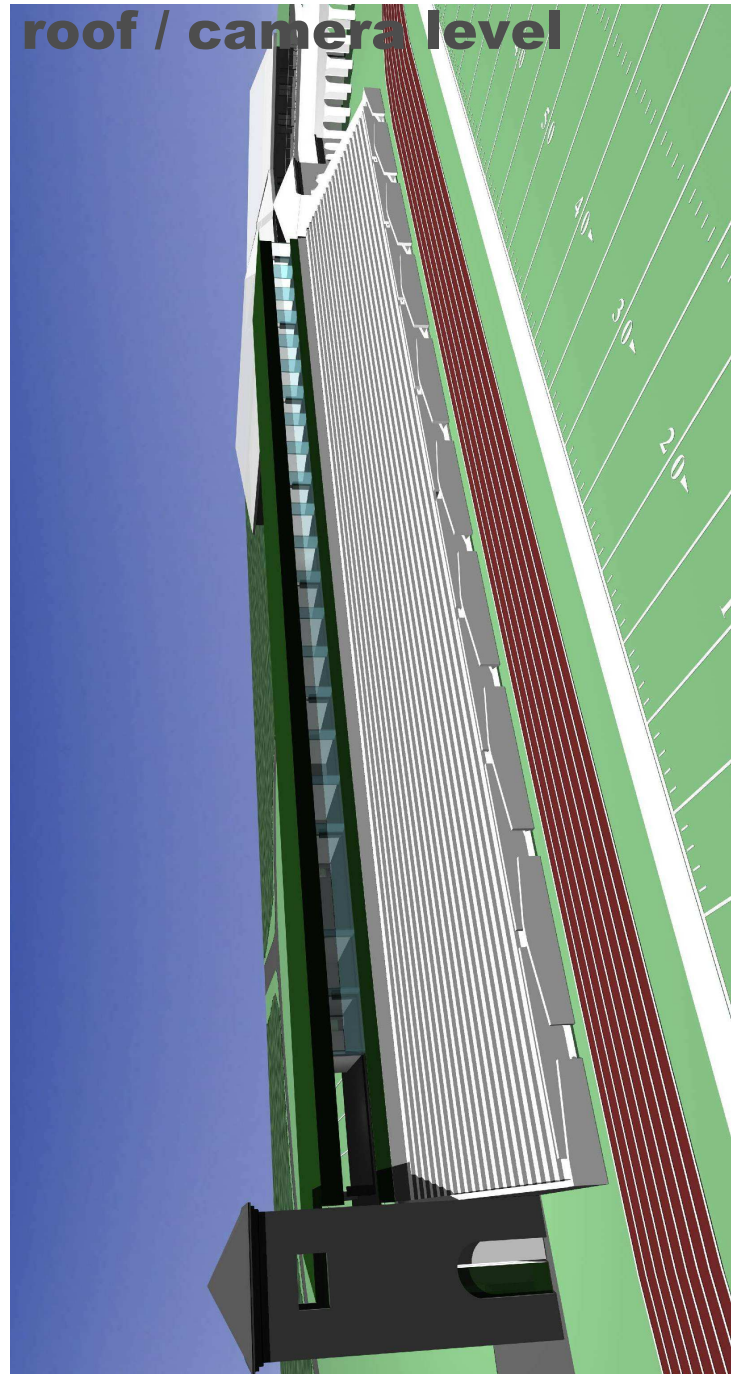
Option 1 – Replacement Including Suites
roof / camera level

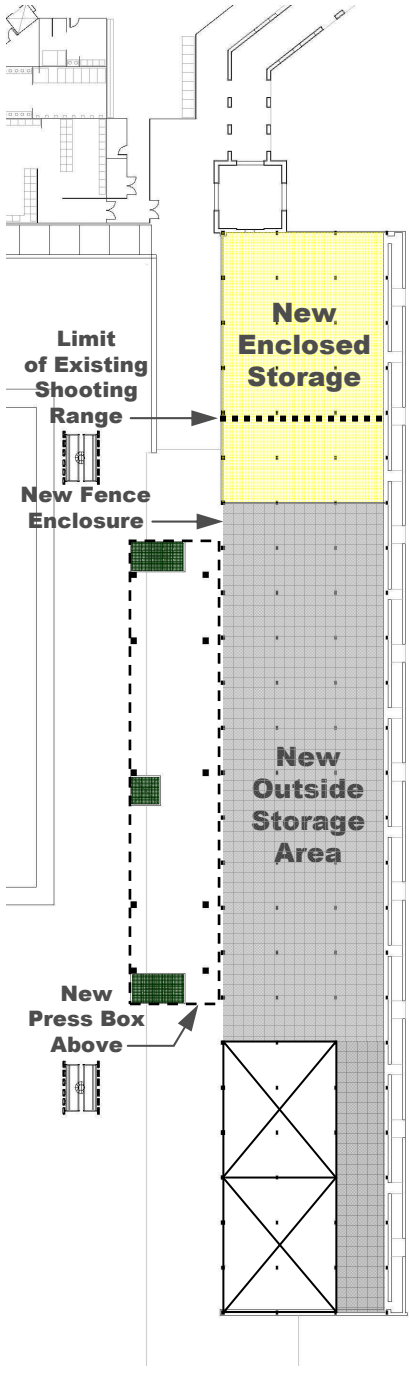
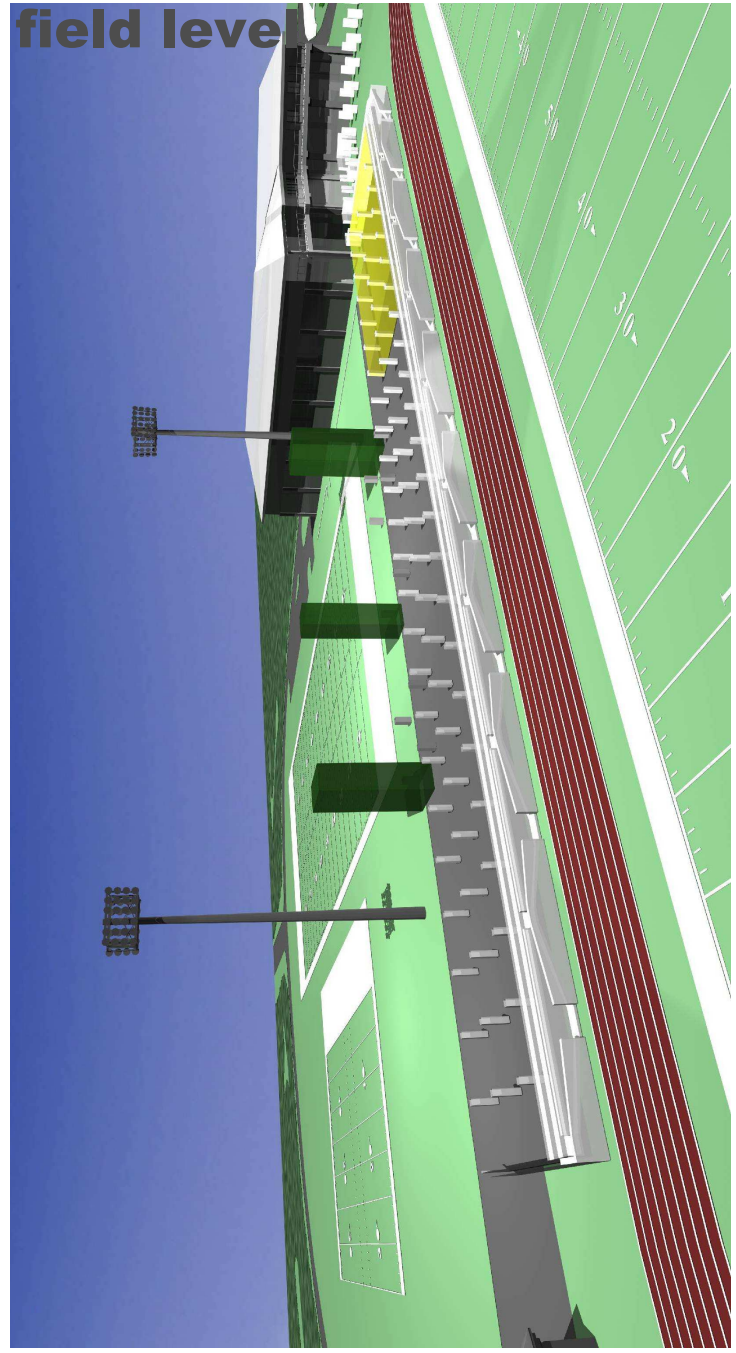
Option 2 – Press / Ops only
field level

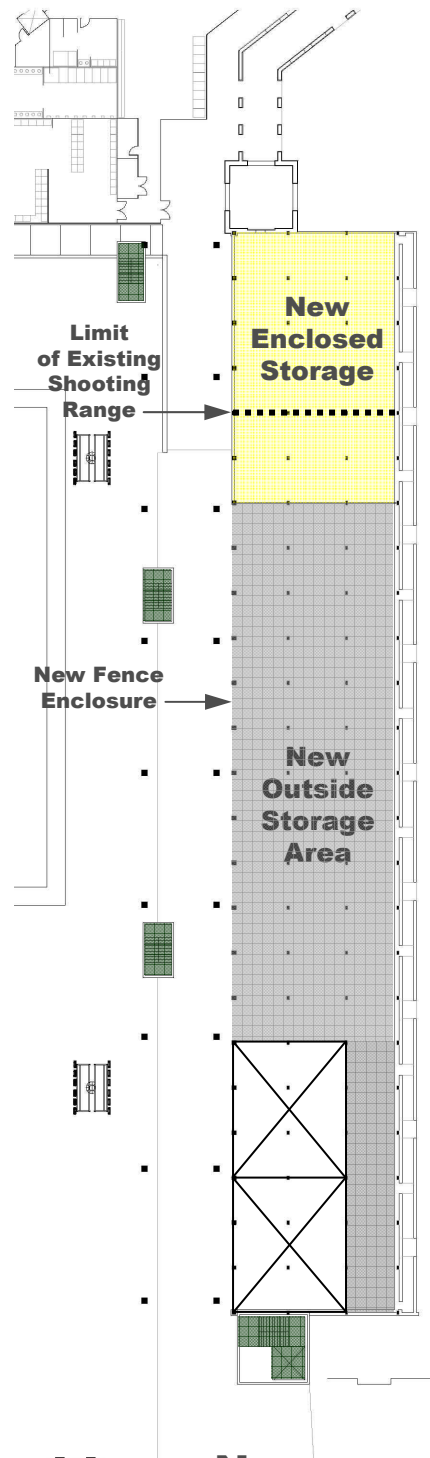
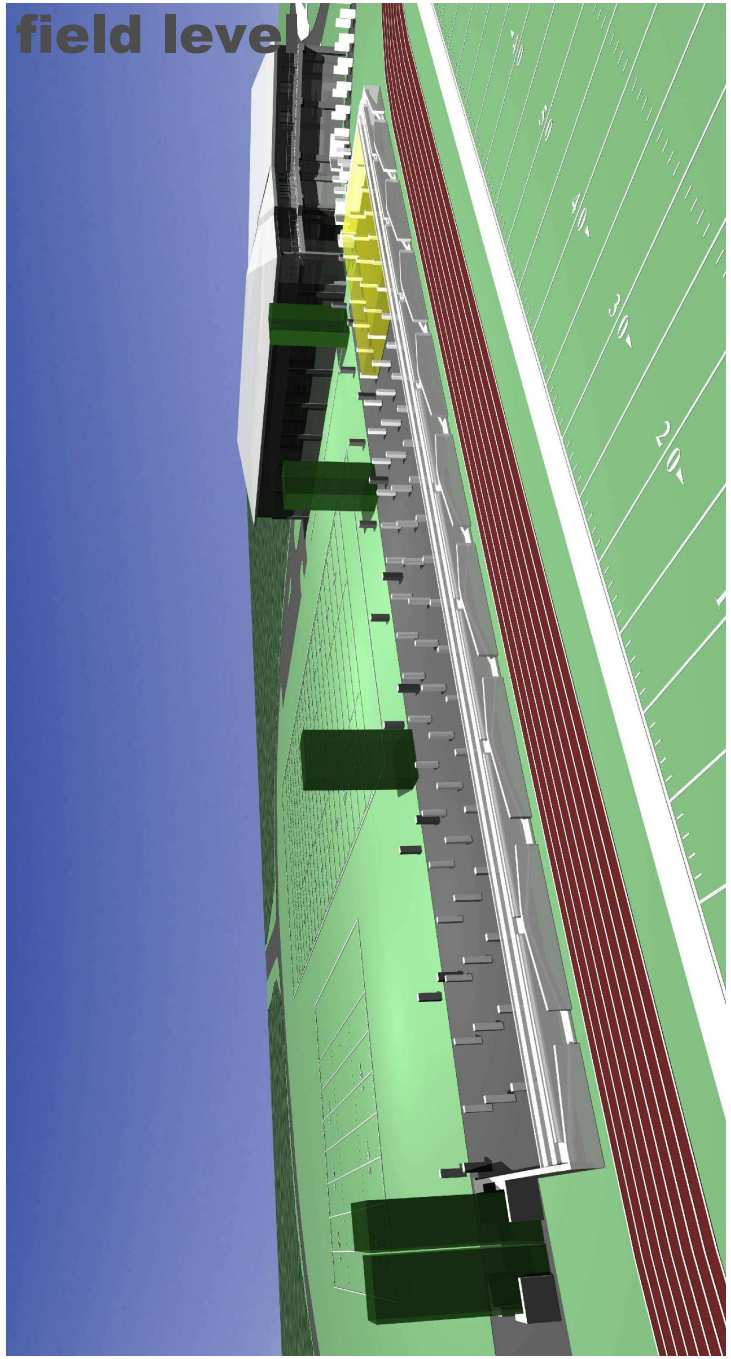
West Stands Coaches / Press Box, Suites, and New Seating

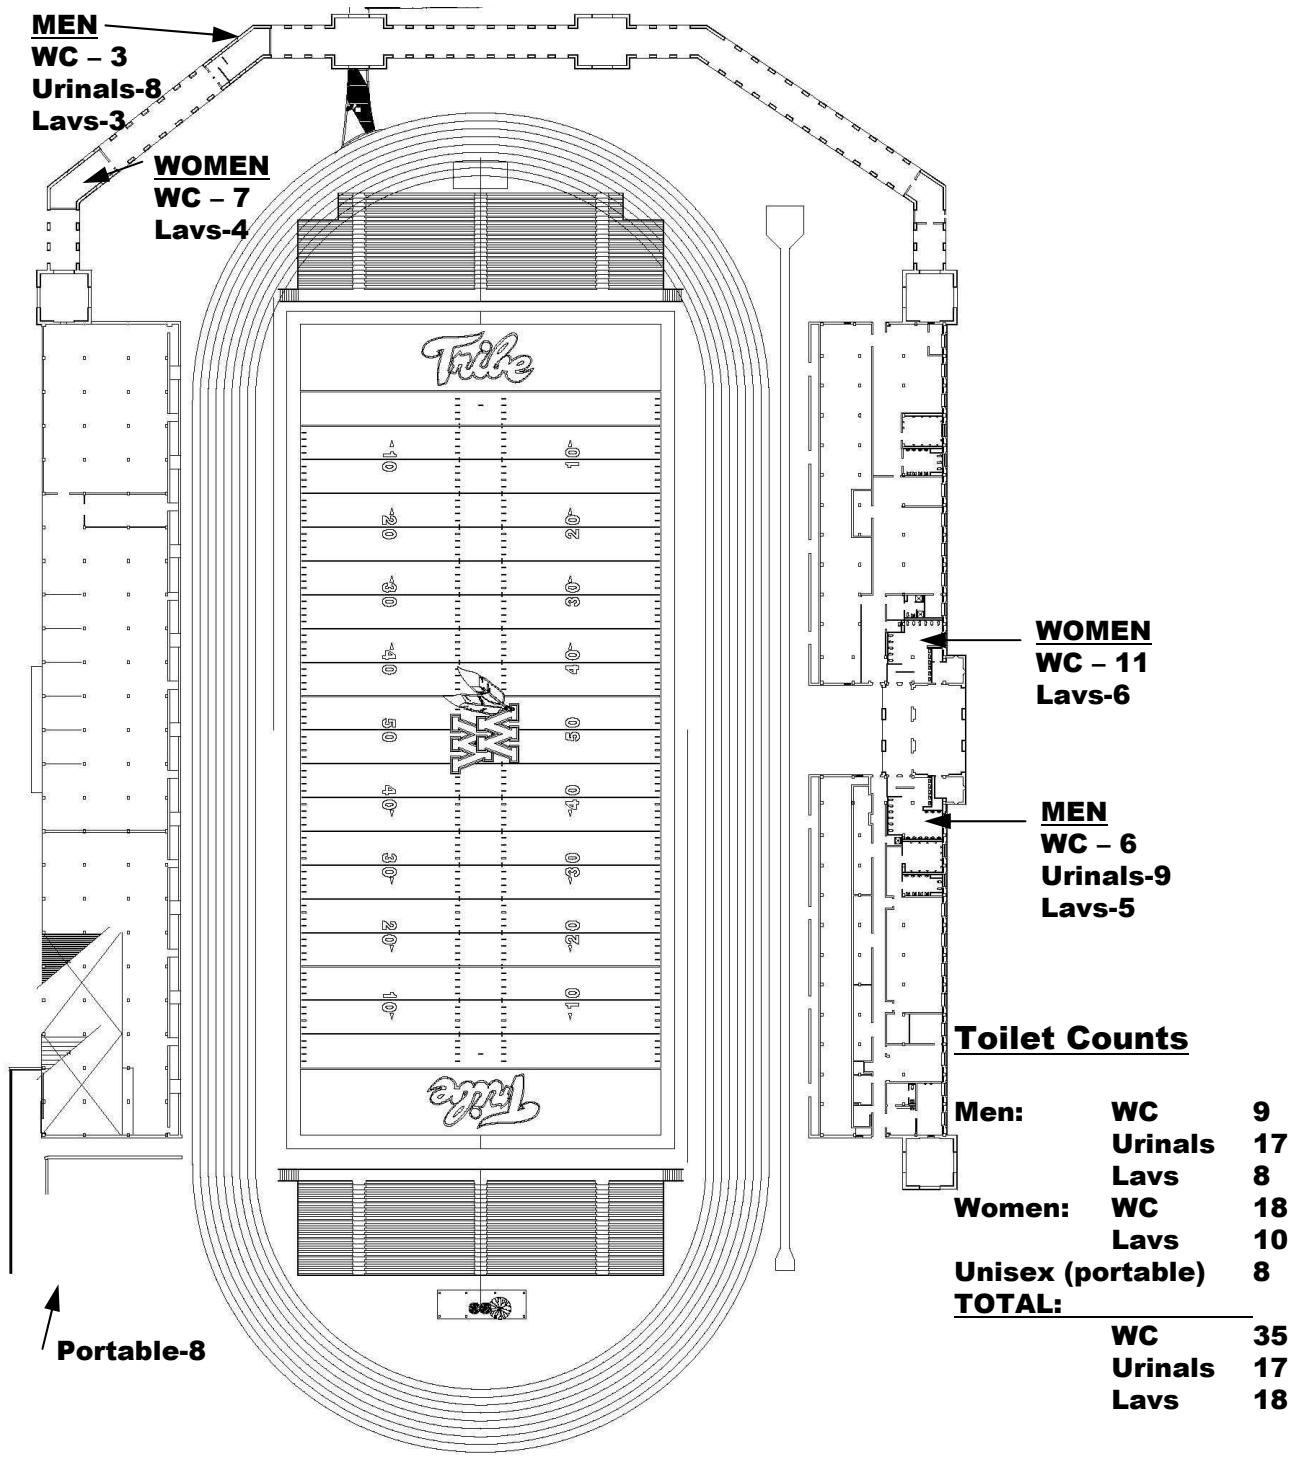
Zable Stadium Existing Conditions

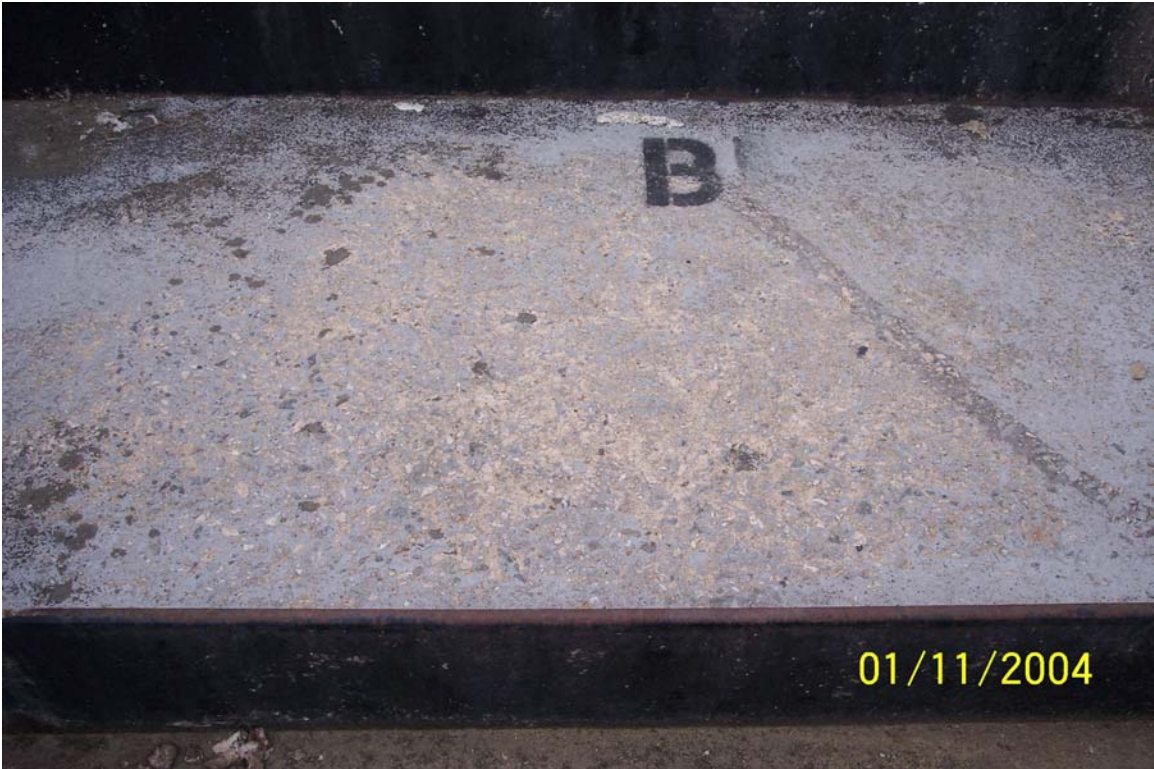
Photograph No. 1
Typical Light Abrasion to Concrete Deck and wear to the coating system

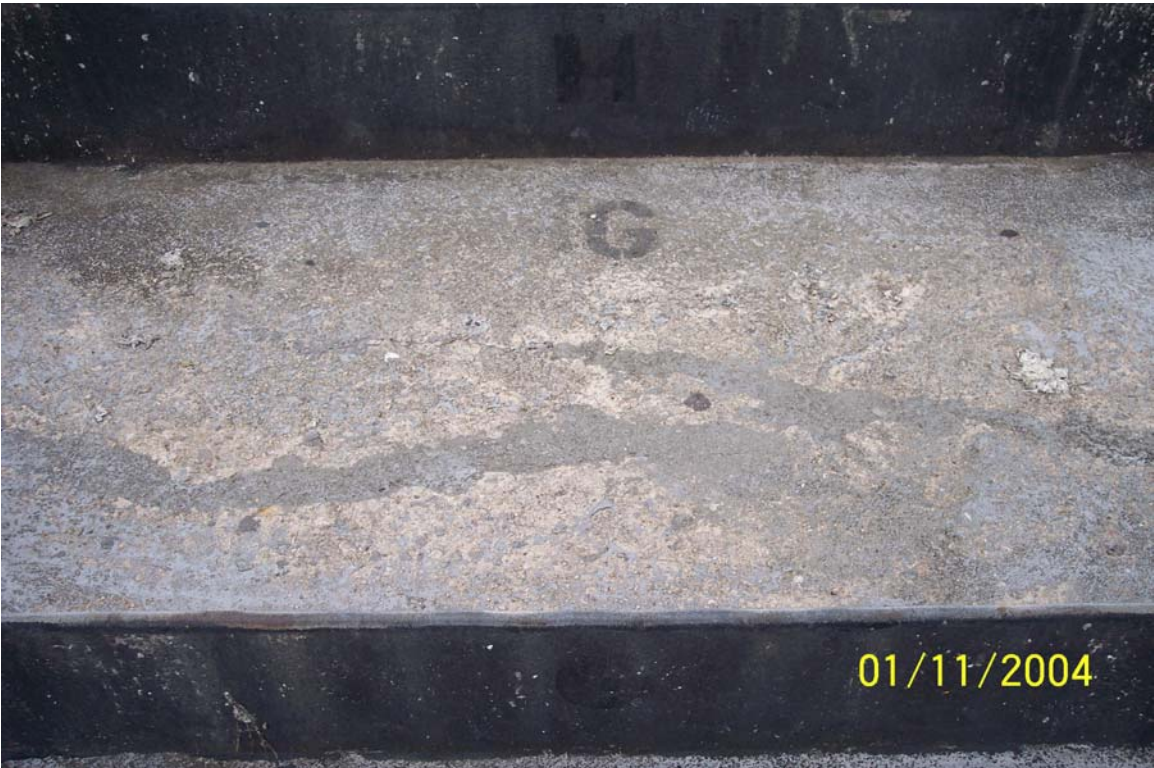
Photograph No. 2
Typical Moderate Abrasion to Concrete Deck requiring chipping away of loose aggregate

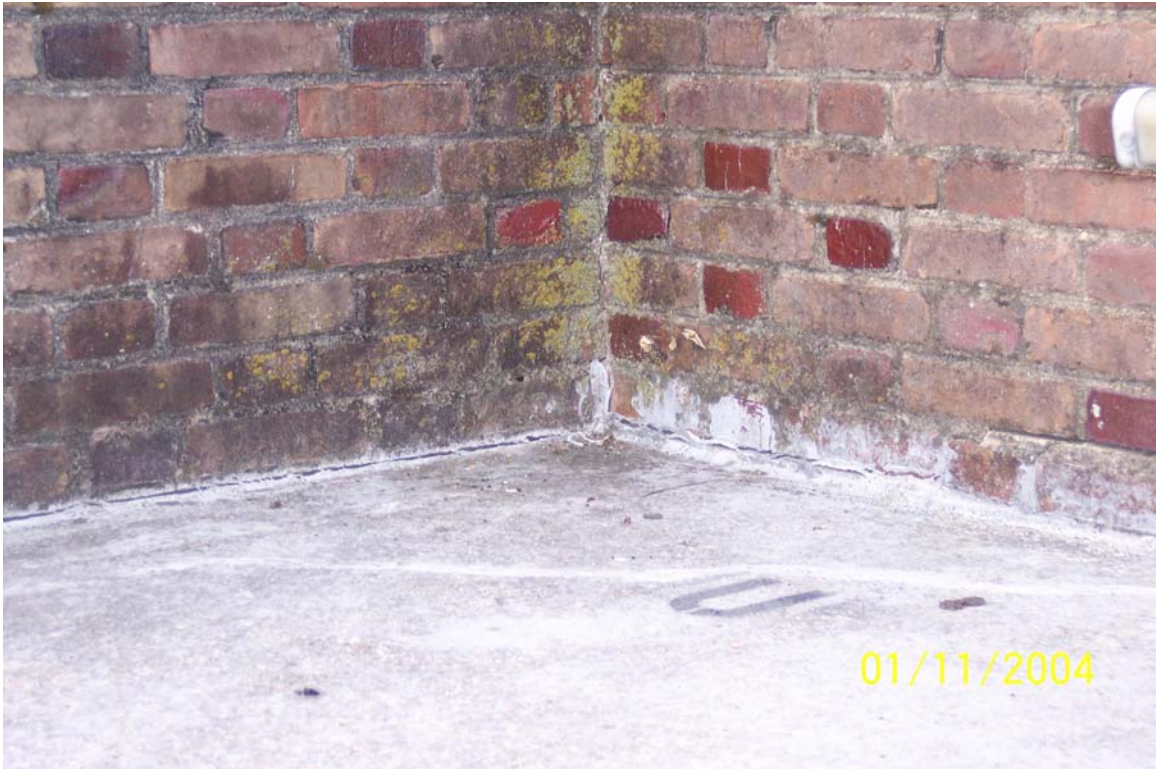
Photograph No. 3
Horizontal crack at base of concrete deck. Notice temperature crack diagonal to wall corner.

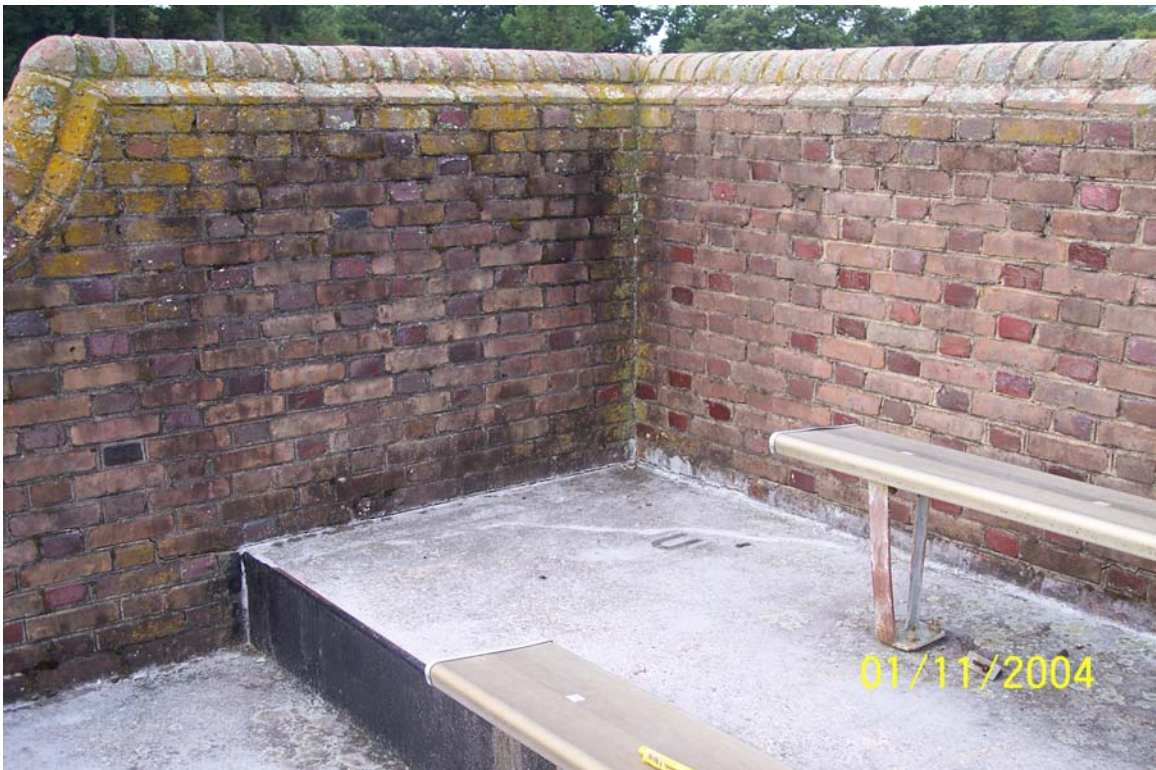
Photograph No. 4
Full view of wall cracks at southwest corner of stadium. Cracks extend up from deck to top of wall and follow temperature crack in deck

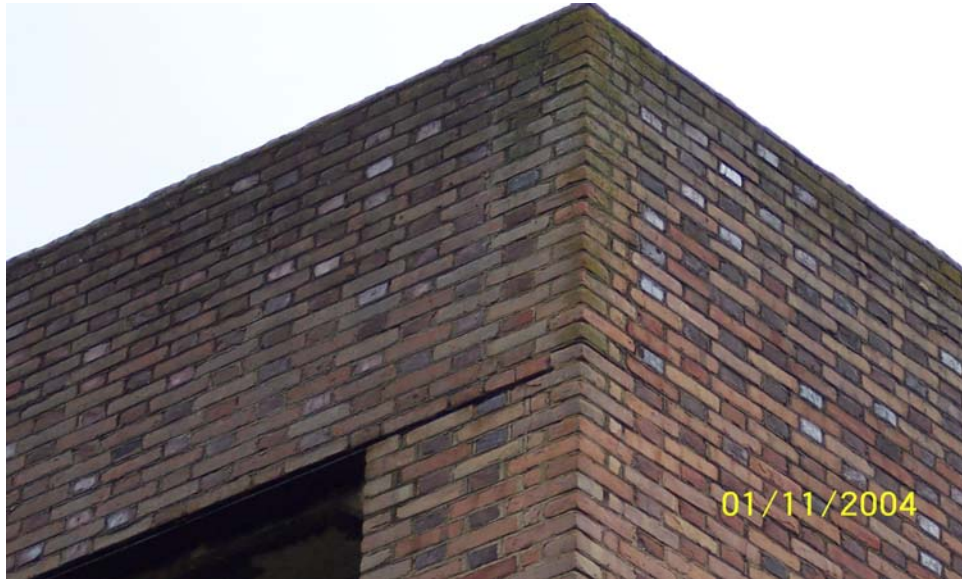
Photograph No. 5
Crack at southwest corner. Notice brick has moved away opening at a result of thermal expansion

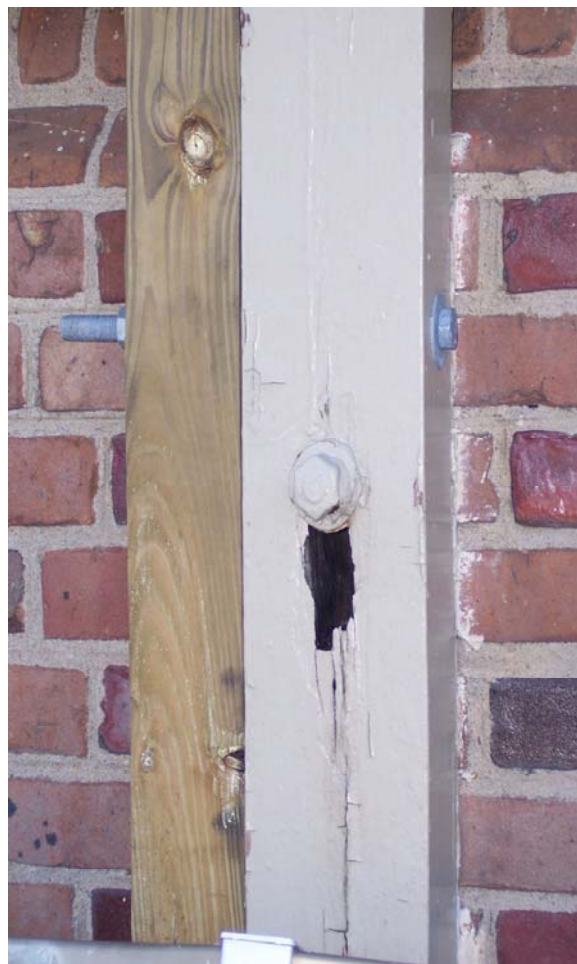
Photograph No. 6
Typical extensive wood rot on press box posts
(Note: 4x4 posts added later for strengthening)

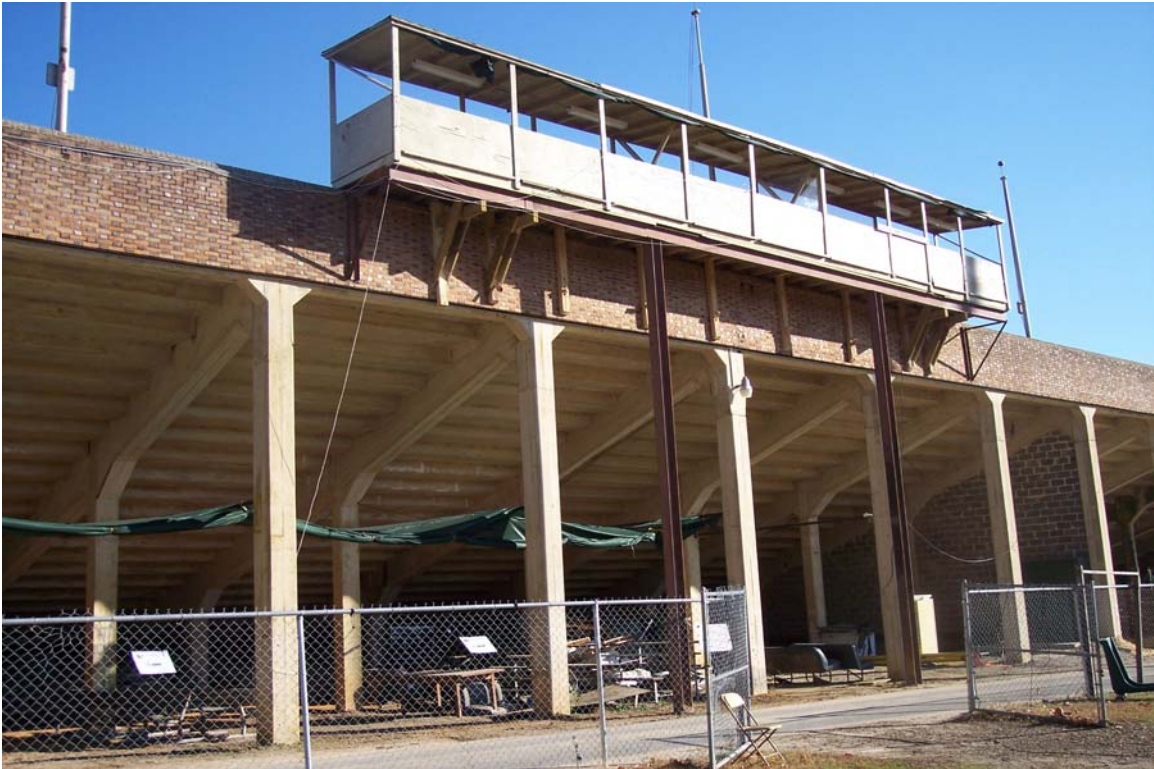
Photograph No. 7
Steel shoring on wooden press box.

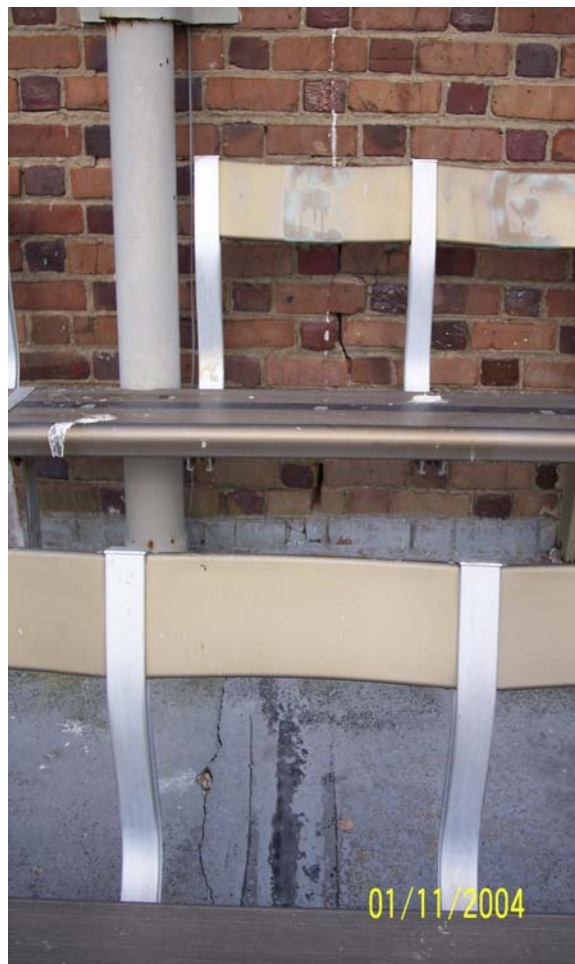
Photograph No. 10
Crack in inside of upper wall and spall in construction joint at column line 13
