THE COLLEGE OF WILLIAM AND MARY

Zable Stadium Feasibility Study

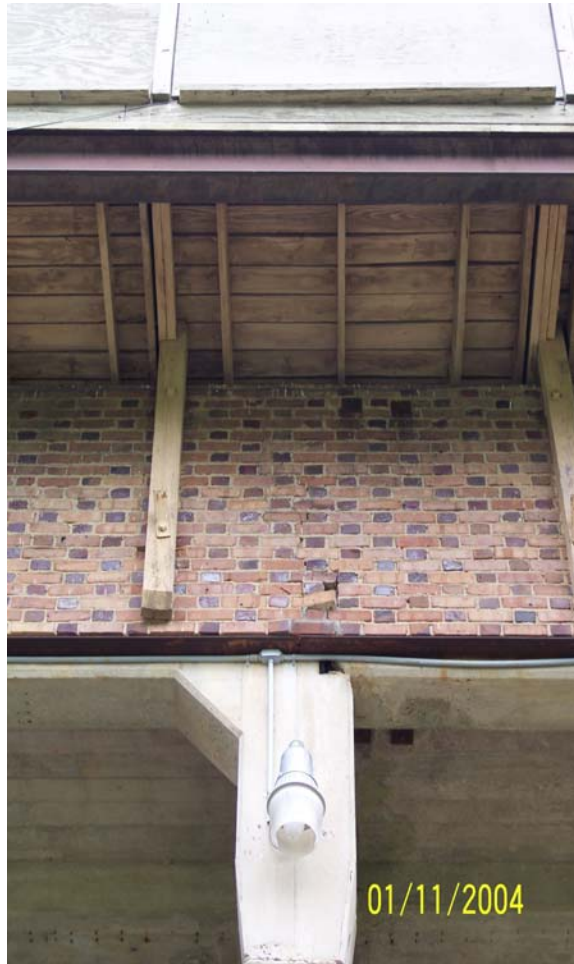
Photograph No. 11
Crack on outside of wall at column line 13. Notice loose brick just above light fixture.

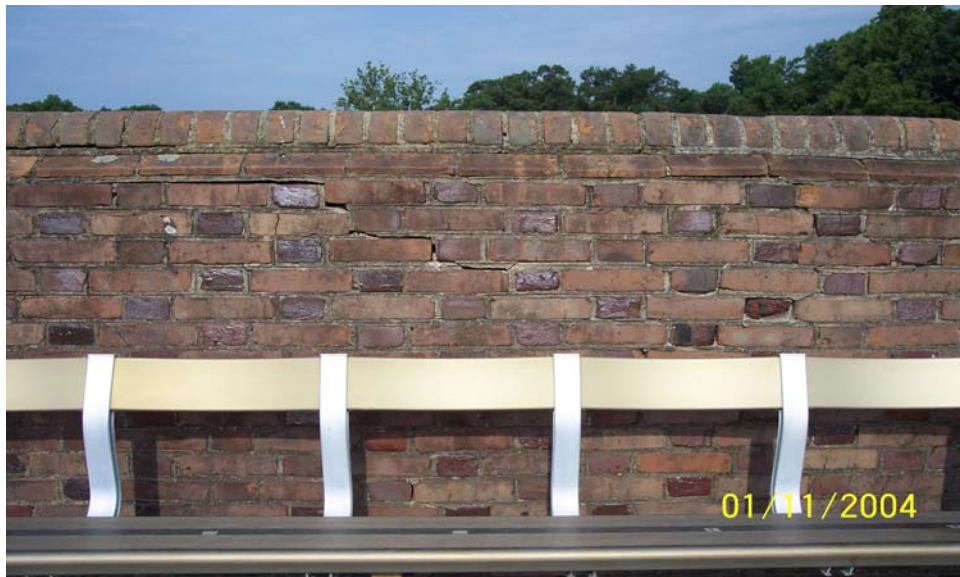
Photograph No. 12
Crack in upper inside wall at column line 19 construction joint

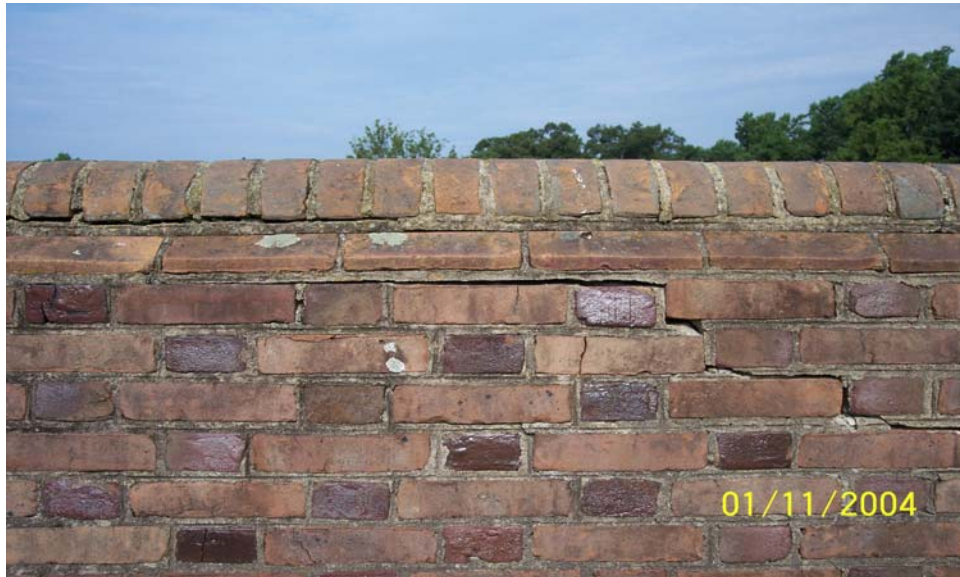
Photograph No. 13
Enlarged photo of crack in upper wall at column line 19 construction joint

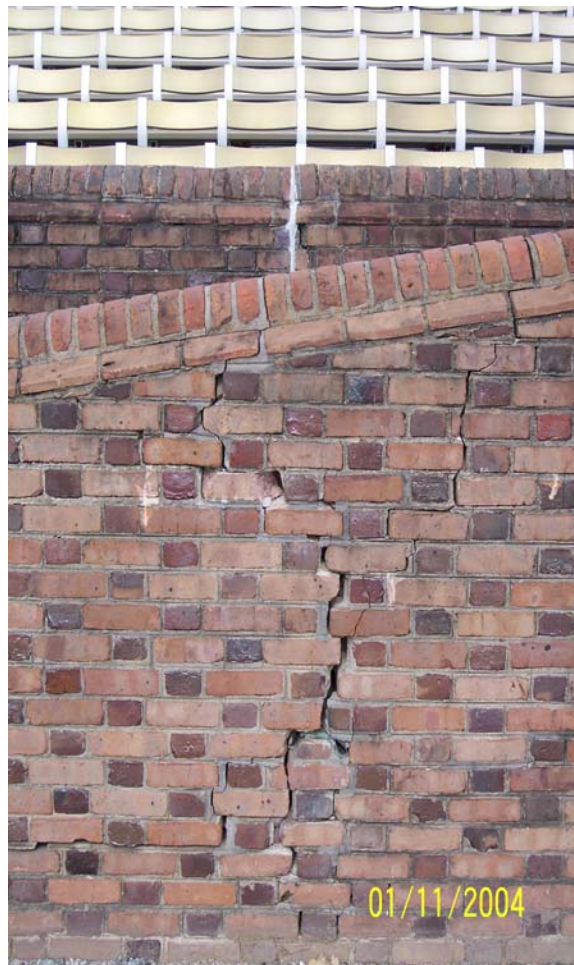
Photograph No. 14
Large crack and brick movement in lower walls at column line 19 due to thermal expansion at construction joint

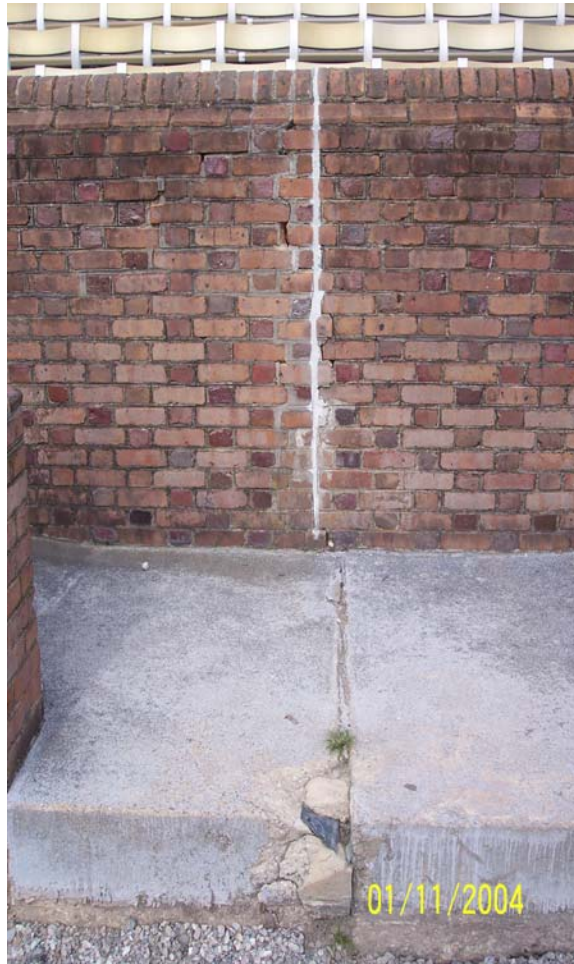
Photograph No. 15
Crack in lower walls at column line 13 due to thermal expansion at construction joint.
Past crack was repaired

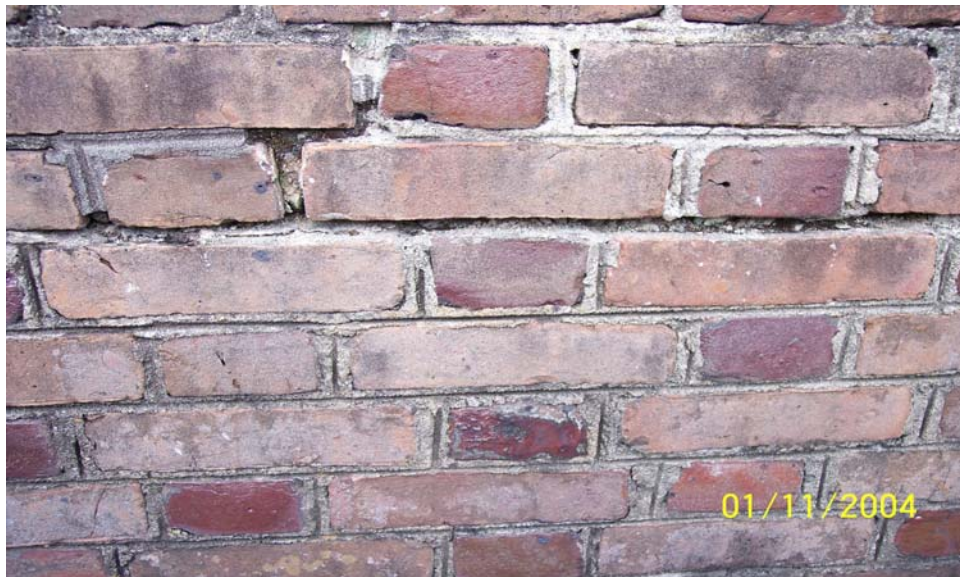
Photograph No. 16
Typical brick mortar joints requiring re-pointing

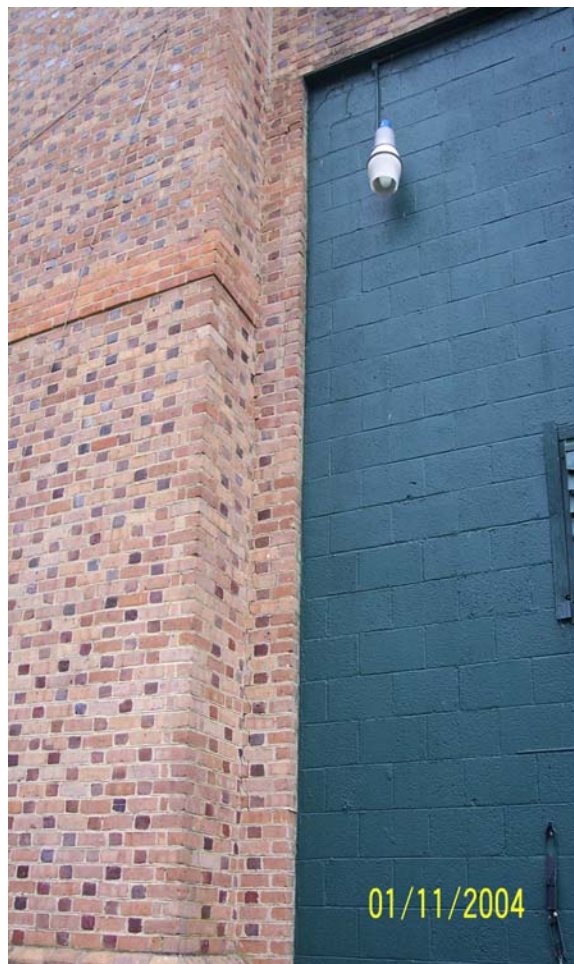
Photograph No. 18
The thermal expansion shown in Photograph 17 has created a full height vertical crack at the wall intersections

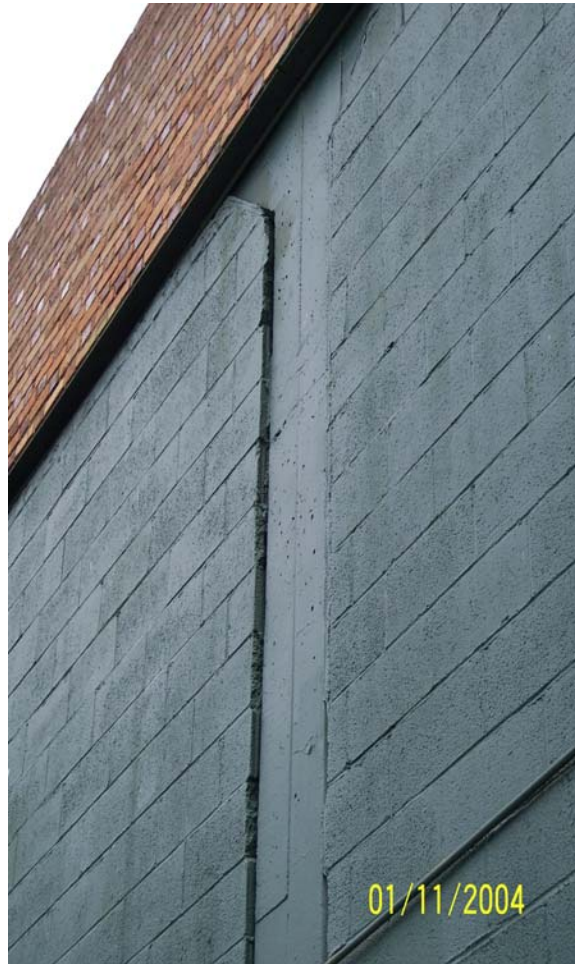
Photograph No. 19 CMU infill wall at column line 22 has tilted outward from frame

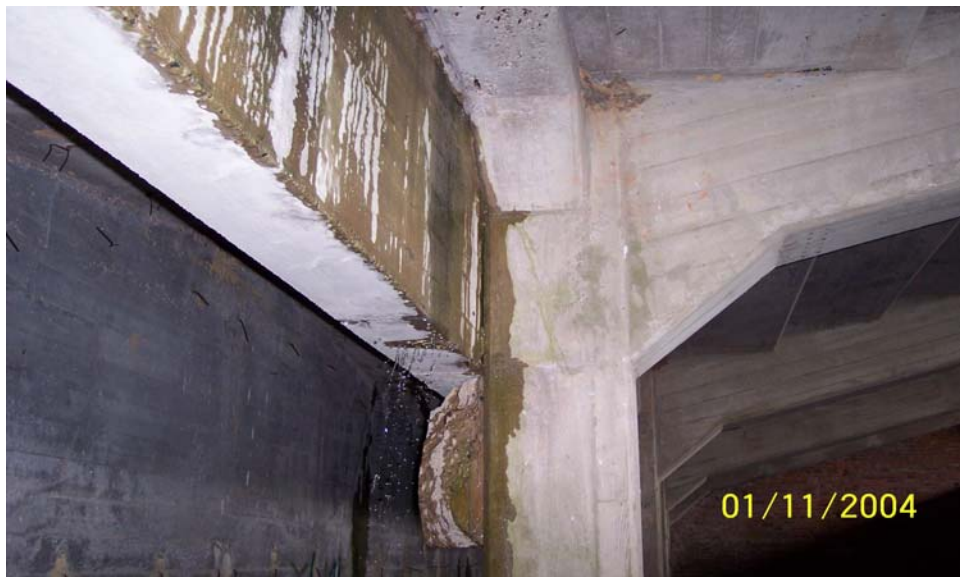
Photograph No. 20
Leaking joint where lower inner wall abuts deck. The transfer beam spanning between the frames supports the inner brick wall. Notice severe spalling of corbel due to water.

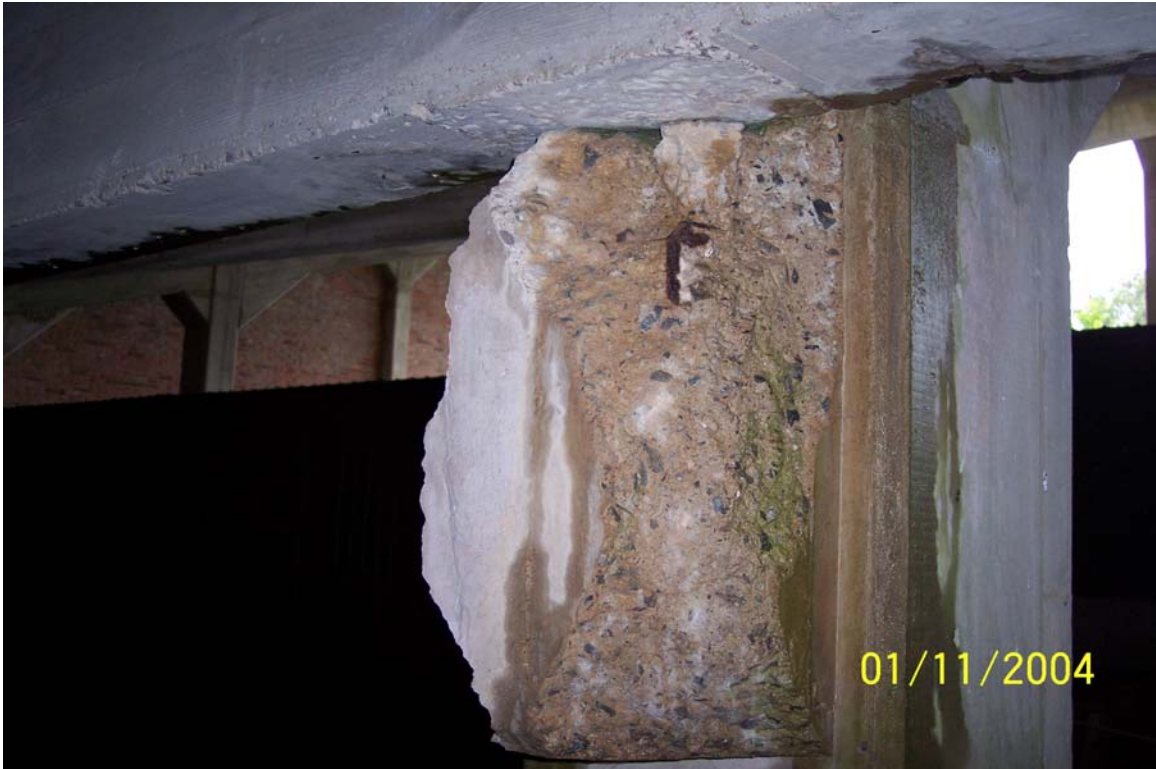
Photograph No. 21
Extensive spalling at concrete corbel

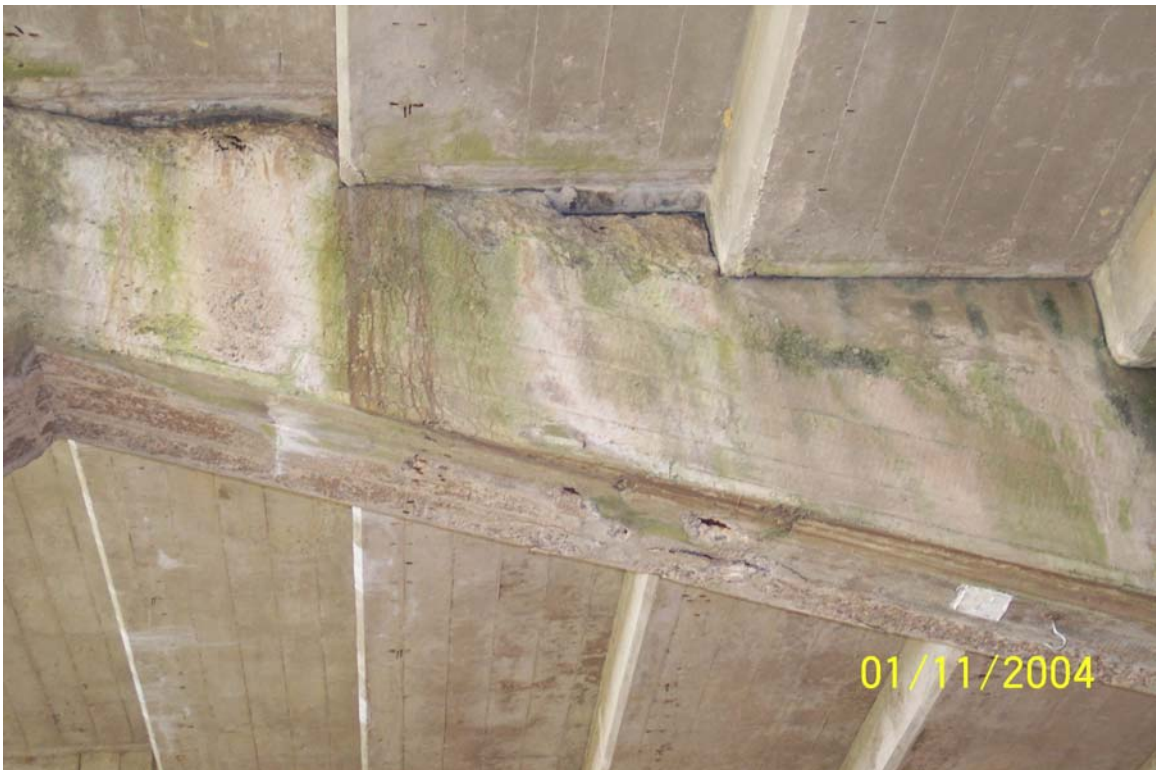
Photograph No. 22
Concrete spalling of bearing seats at construction joints at column lines 7, 14 and 19.

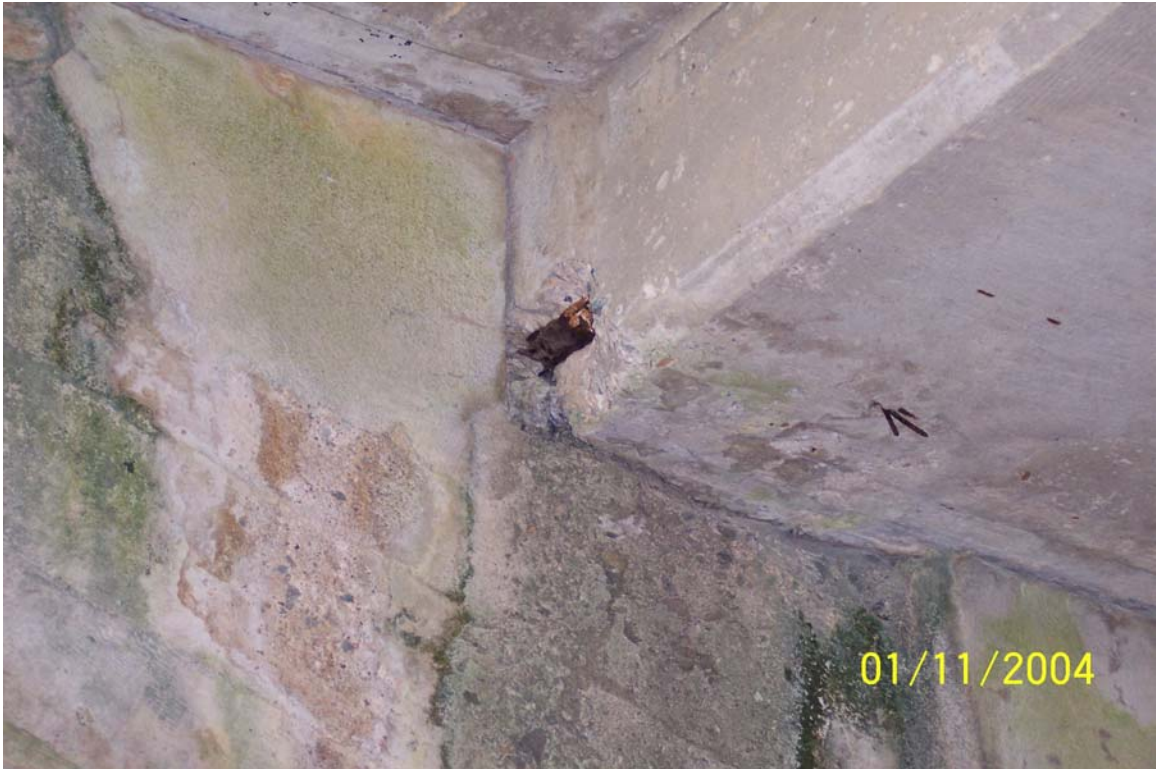
Photograph No. 23
Close up of spalling at bearing seats. Notice exposed main reinforcement due to lack of concrete cover

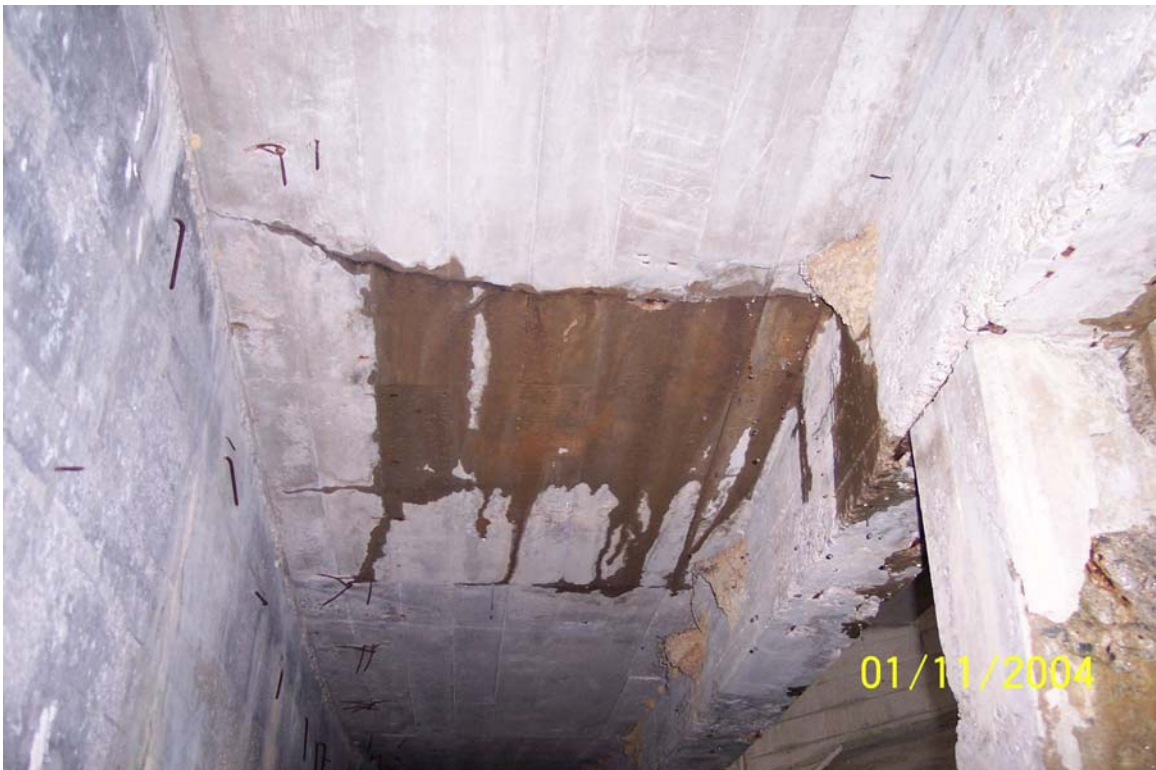
Photograph No. 24
Transverse temperature cracks leaking. This is the concrete ramp between the two lower walls.

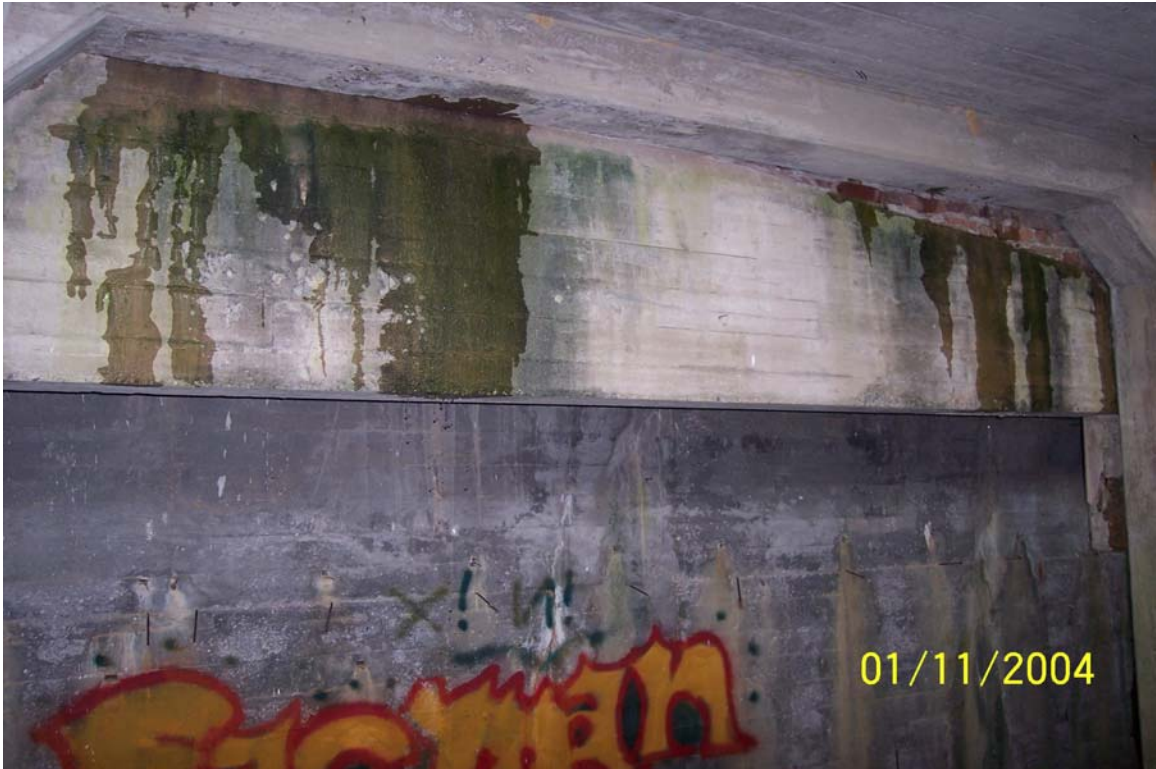
Photograph No. 25
Leaking joint at lower brick wall and supporting concrete beam

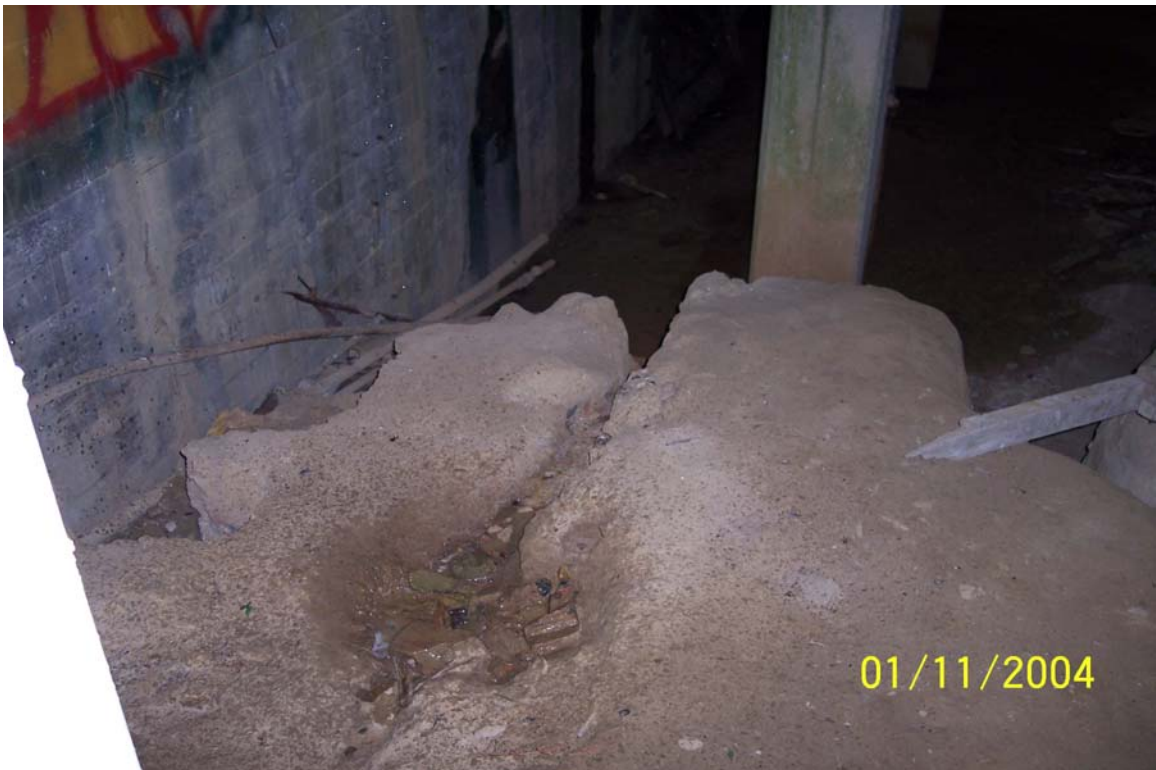
Photograph No. 26
Soil erosion at inner concrete wall which support outer brick wall

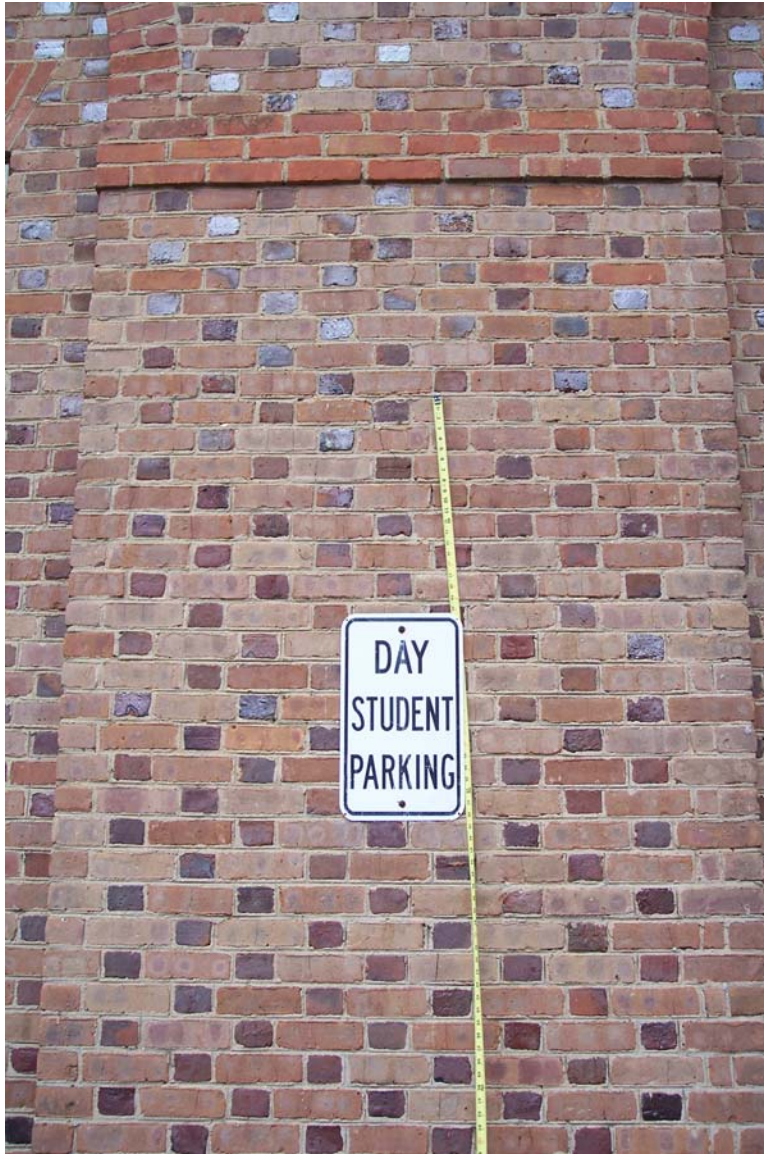
Photograph No. 2
Hairline vertical crack in brick mortar joints and through bricks

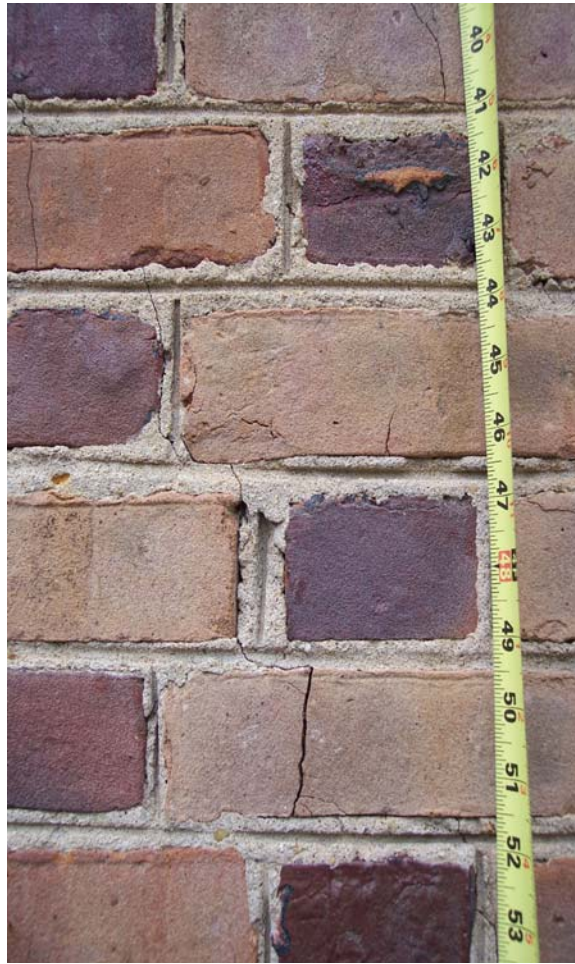
Photograph No.3
Cracks extend through the bricks and follow the mortar joints

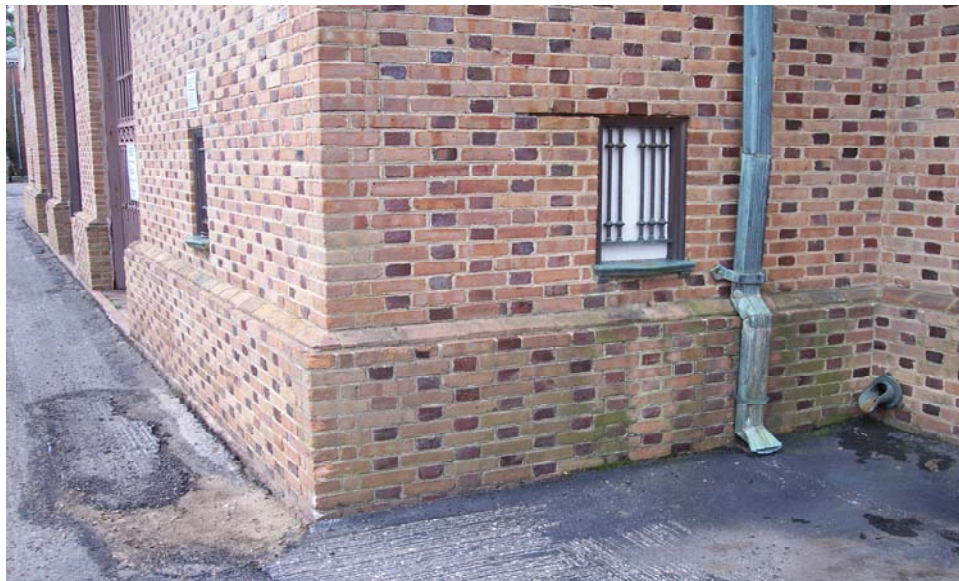
Photograph No. 4
Full view of vertical wall crack at the ticket office along column line 15. Notice presence of ponding water adjacent wall at crack. These are in close vicinity of the roof drain and rain water leader. This is typical on the opposite side

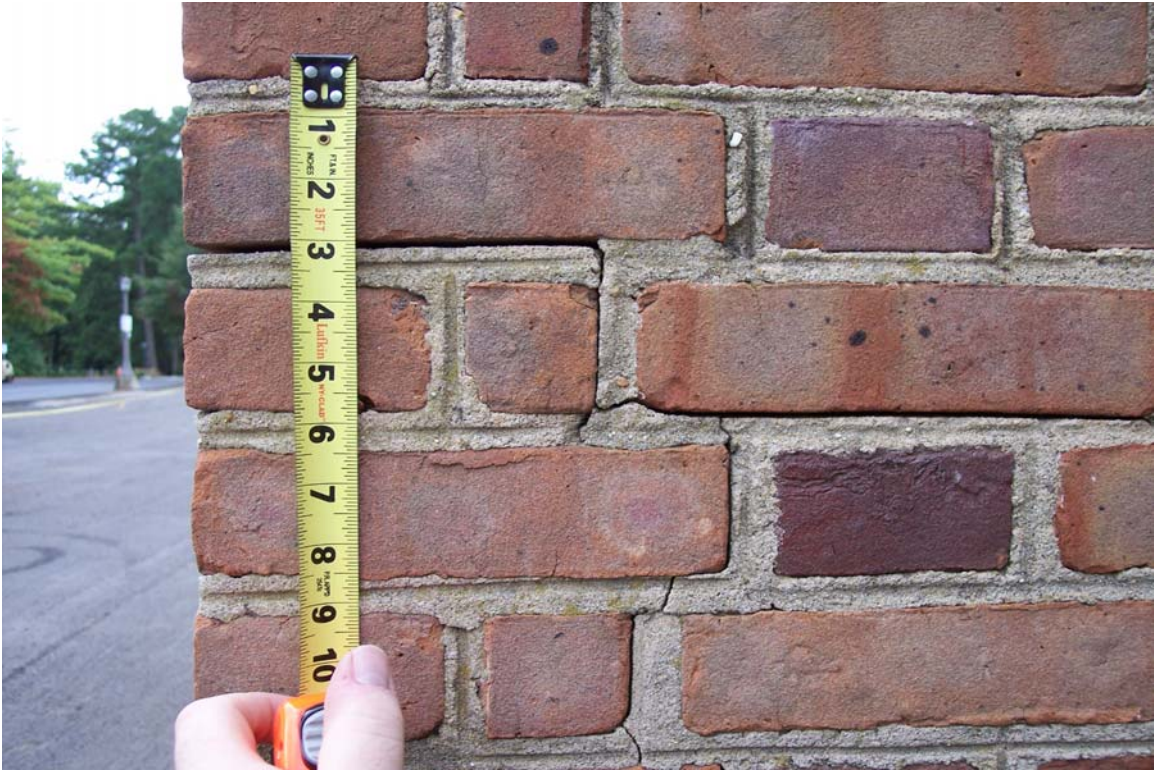
Photograph No. 5
Enlarged view of corner crack. This crack extends full height of the wall and stair steps at the mortar joints

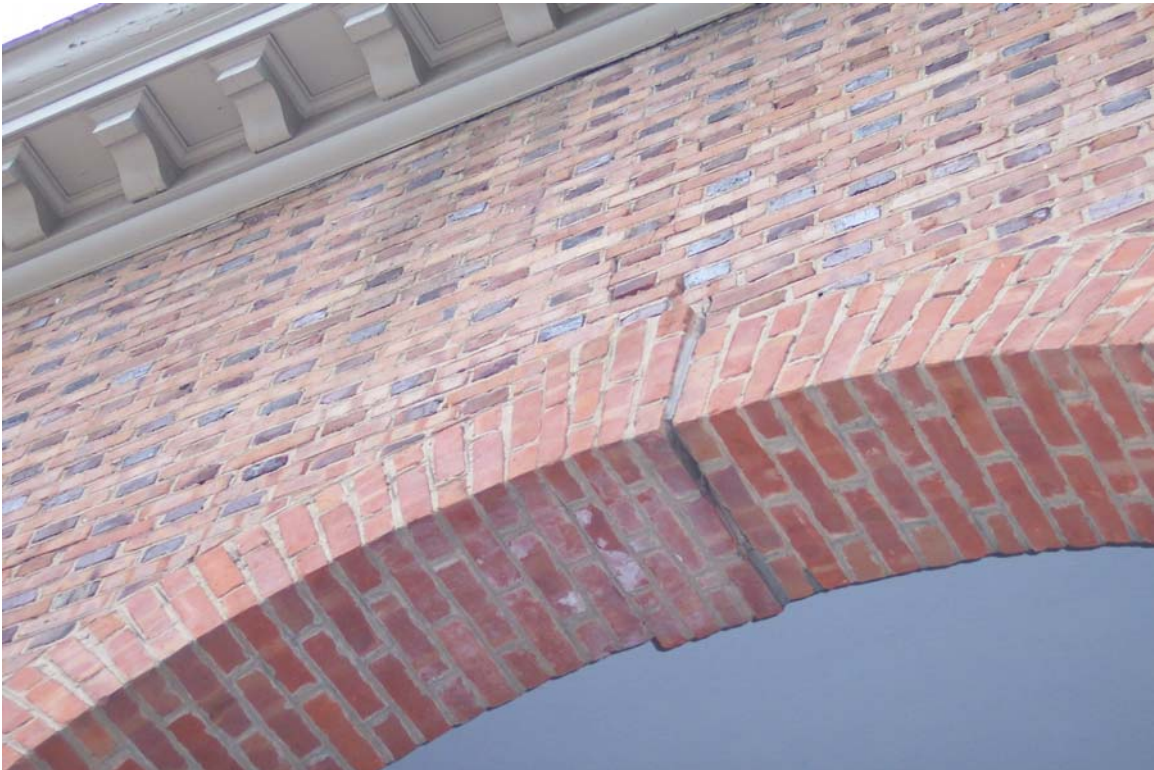
Photograph No. 6
Vertical crack at brick key in arch. The key has dropped down. Crack continues up vertically to the soffit

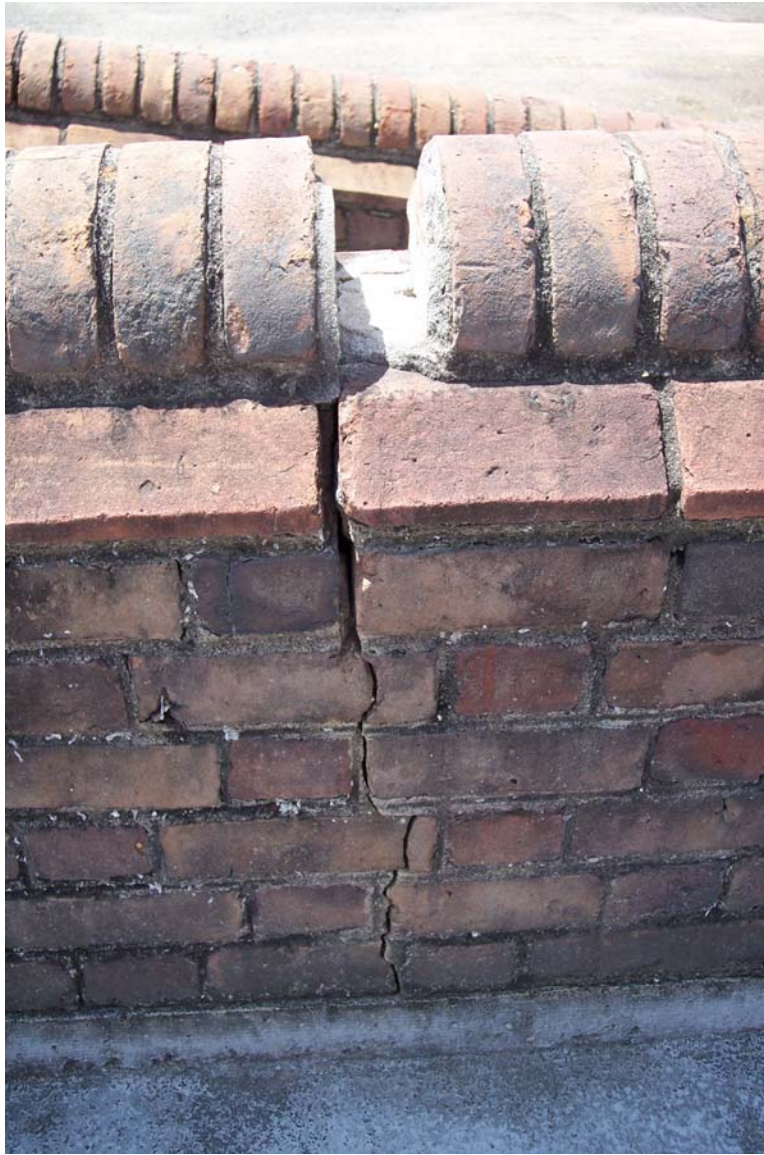
Photograph No. 8
Large thermal crack in lower brick wall

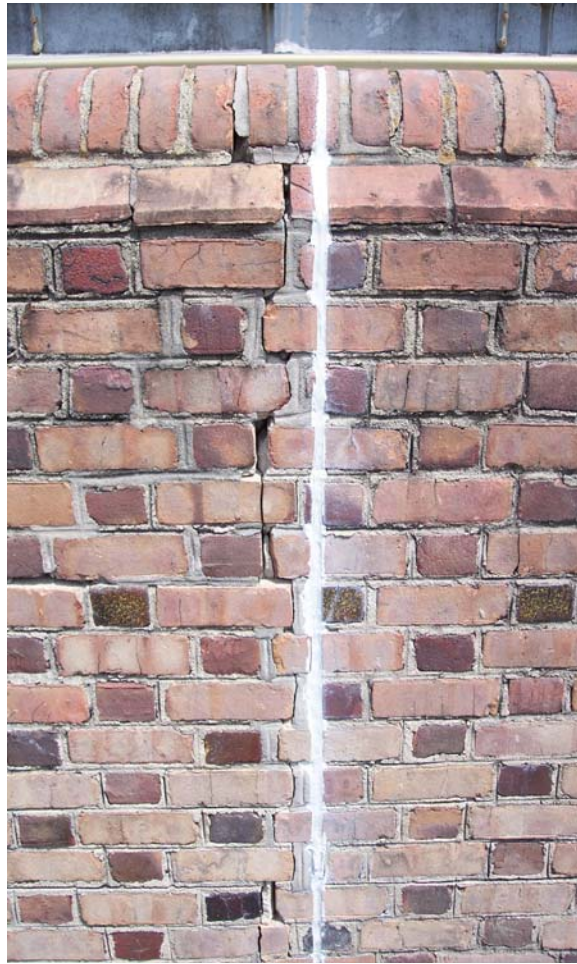
Photograph No. 9
Large crack at construction joint due to thermal expansion

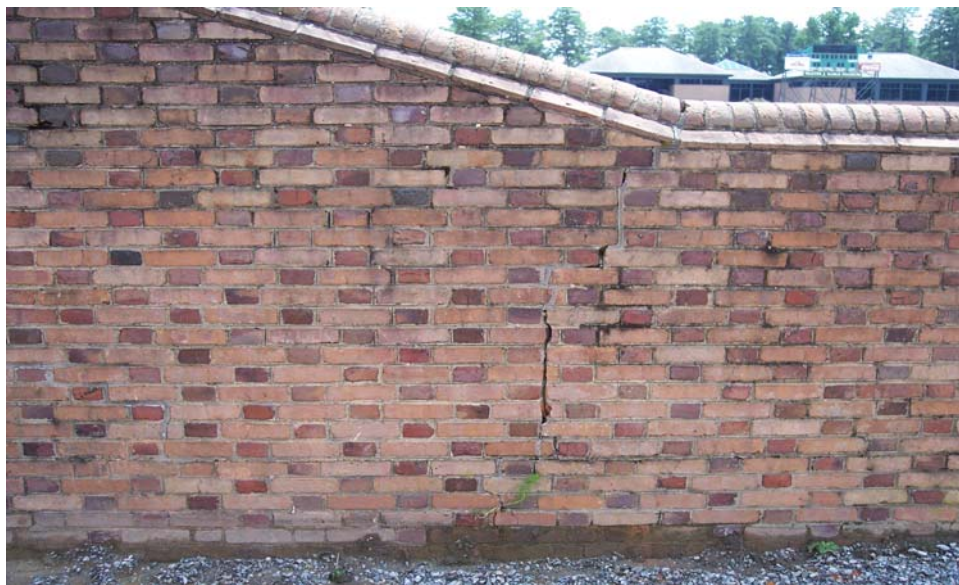
Photograph No. 10
Typical foundation settlement crack on all four brick wingwalls. Underside of deck has erosion due to water infiltration from clogged floor drains

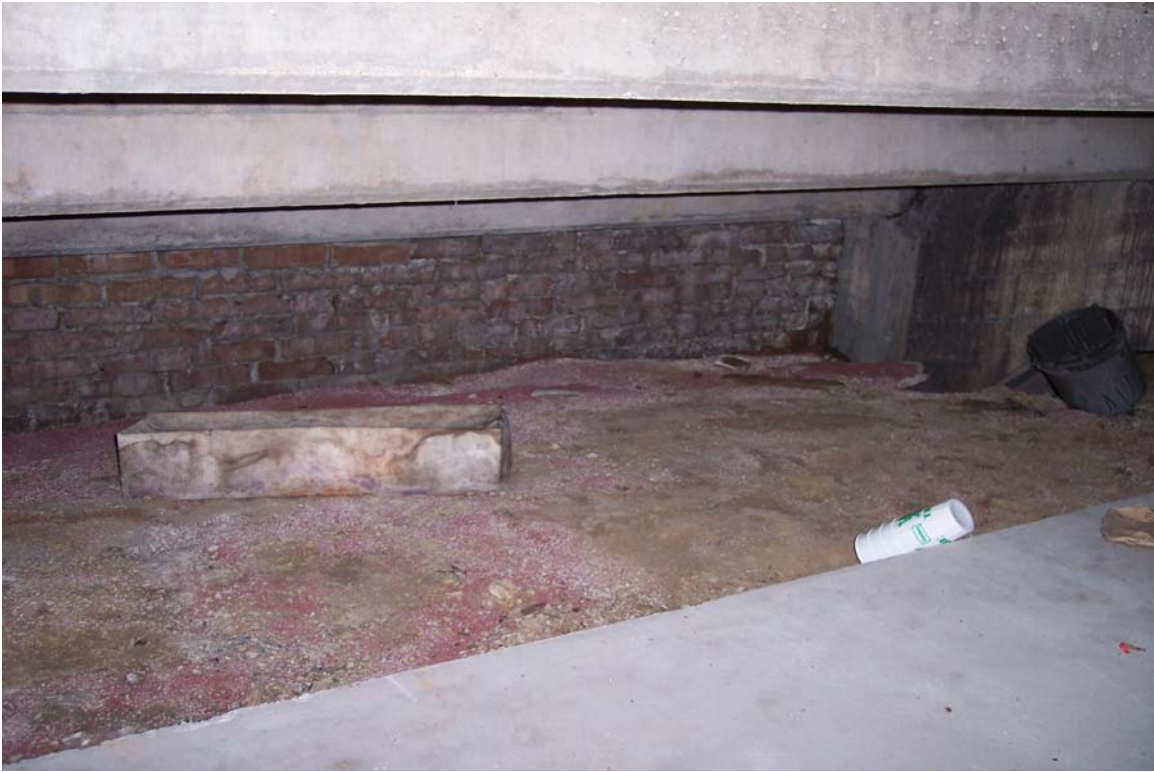
Photograph No. 11
Washout and erosion under at lower wall directly under floor drains

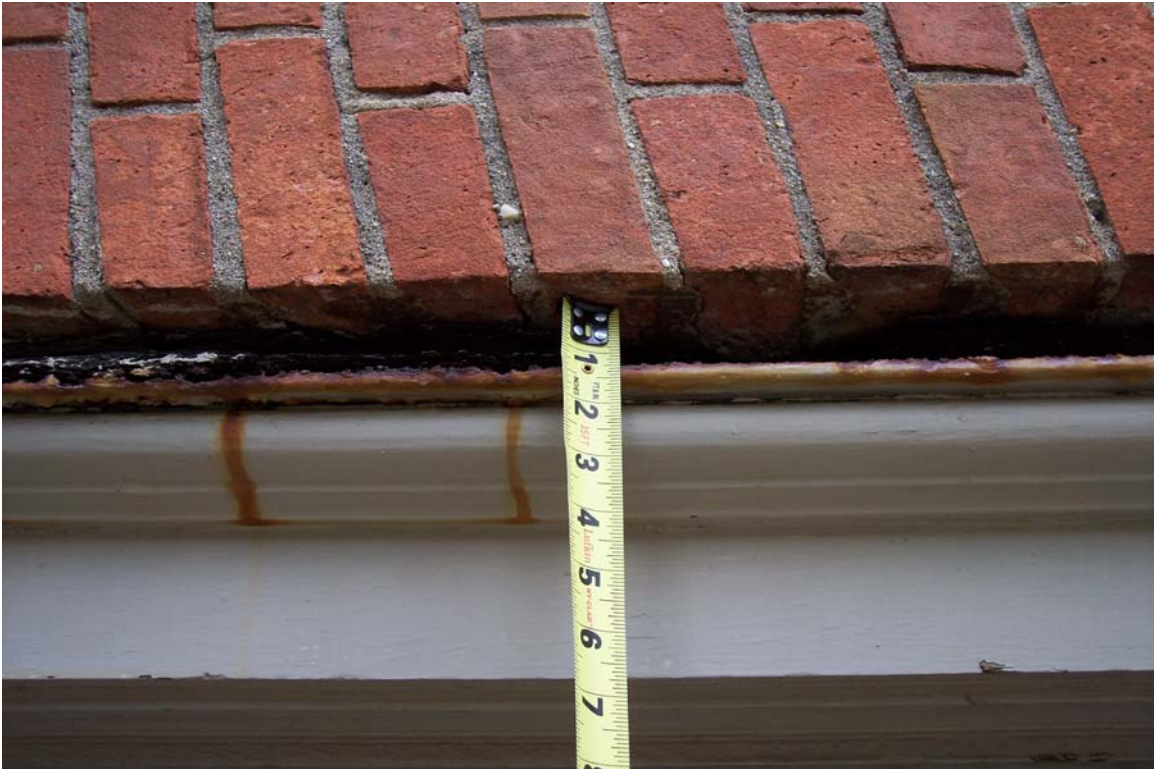
Photograph No. 13
Severely rusted shelf angle

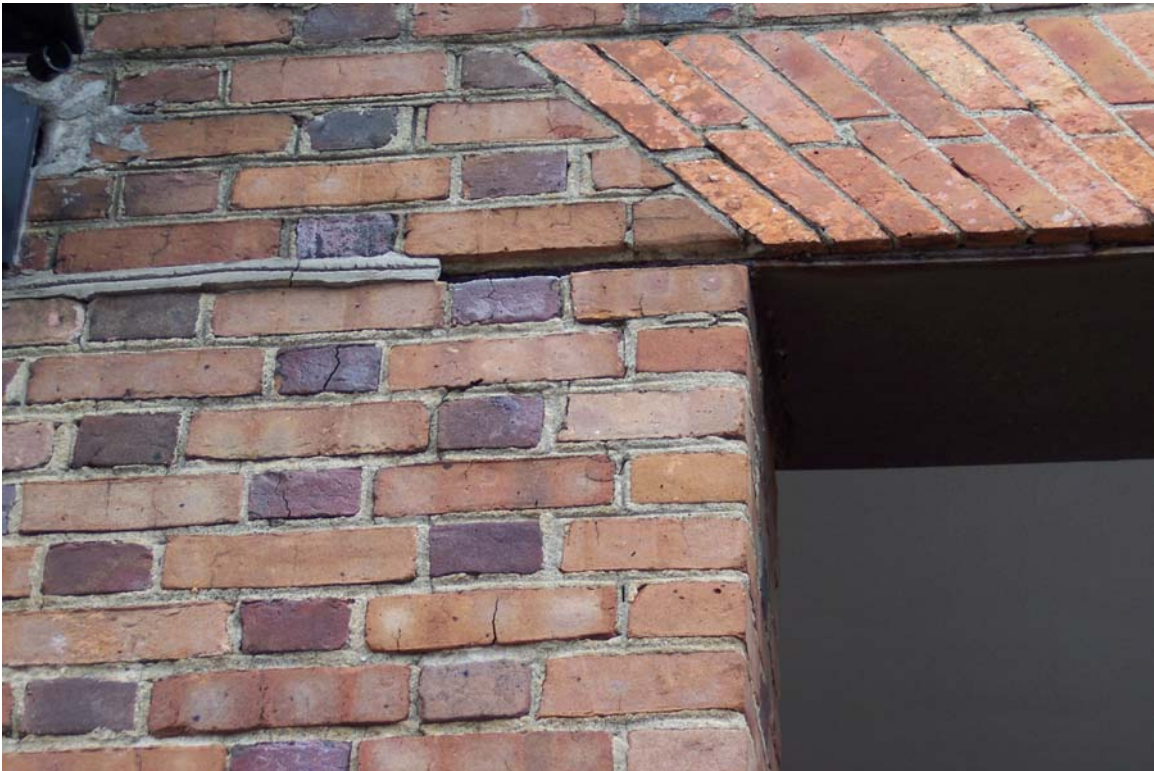
Photograph No. 14
Rusted shelf angle. Notice expansion of steel due to erosion has broken out previously repaired mortar joint

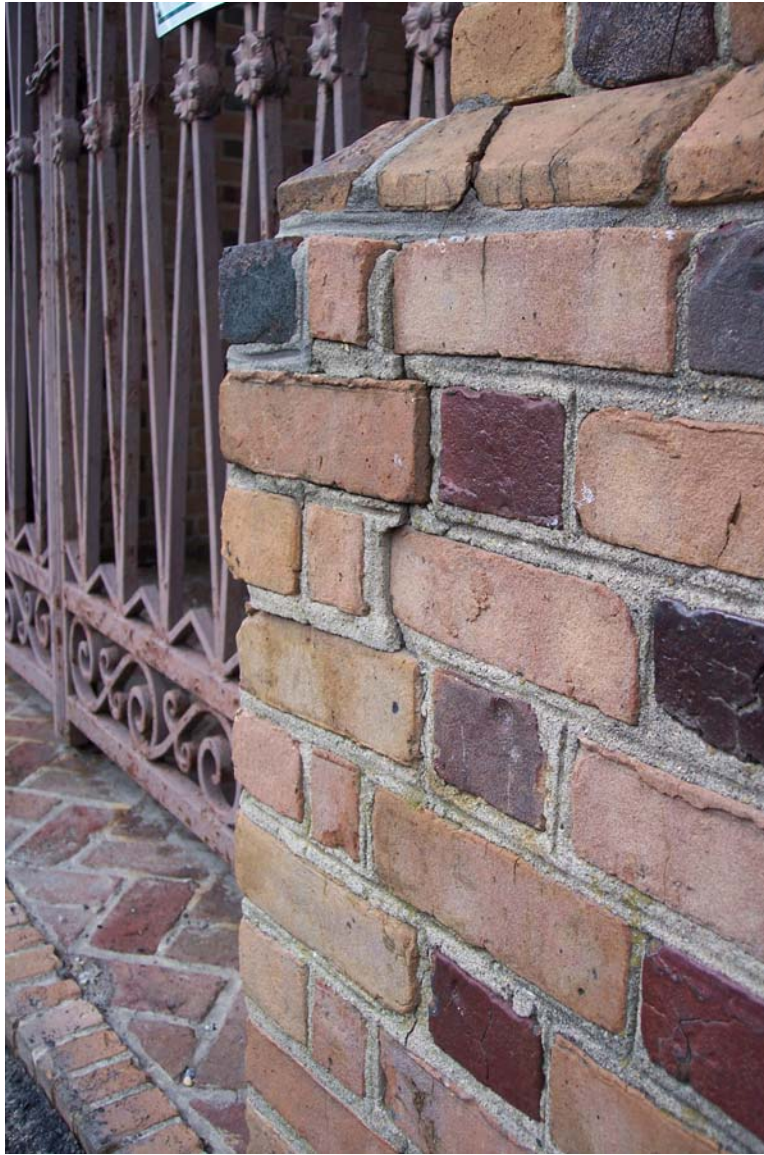
Photograph No. 16
This picture shows movement of brick at steel frame due to steel corrosion

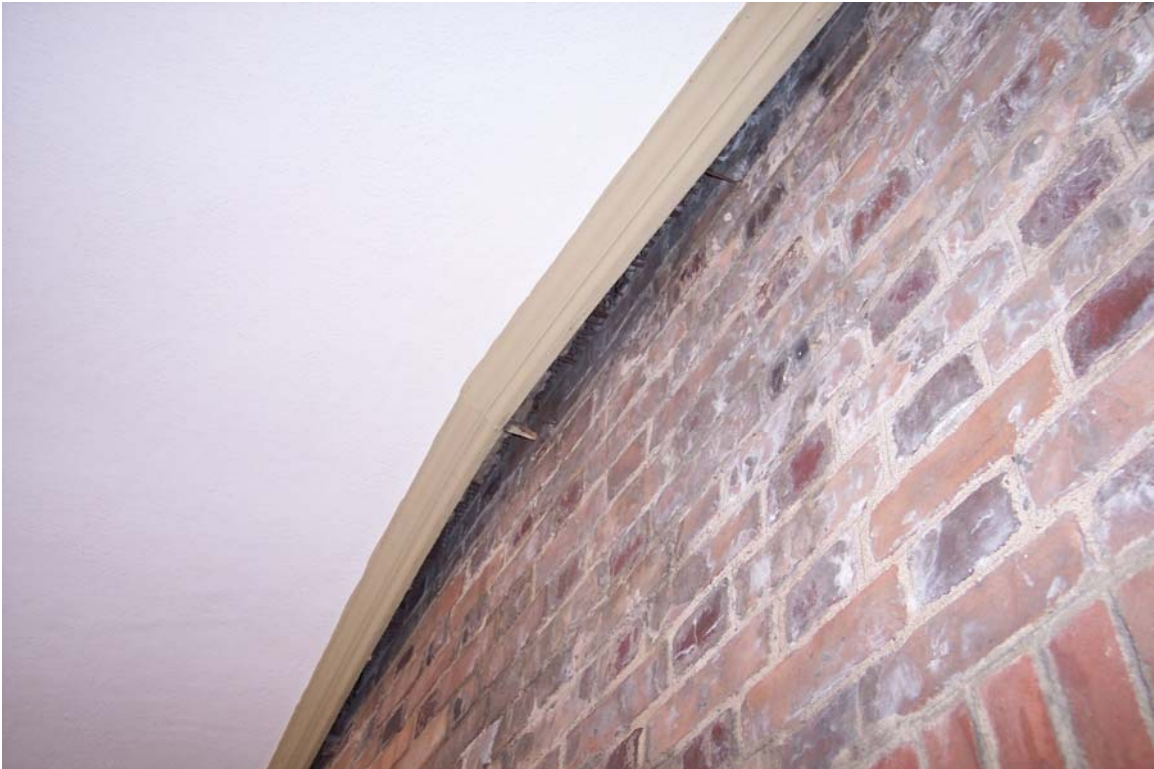
Photograph No. 17
Wood nailers have pulled out of brick. The wood trim could pose a safety hazard should it fall.

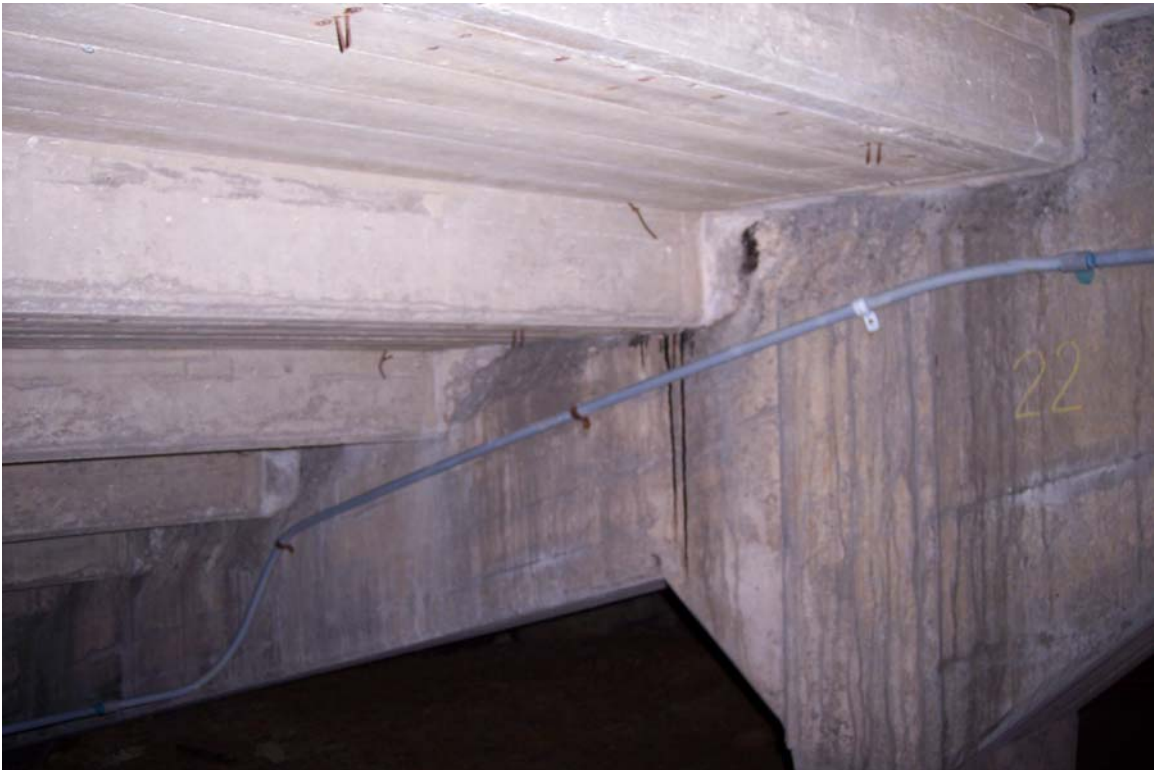
Photograph No. 18
Bearing spalls along top of concrete frame at column line 22

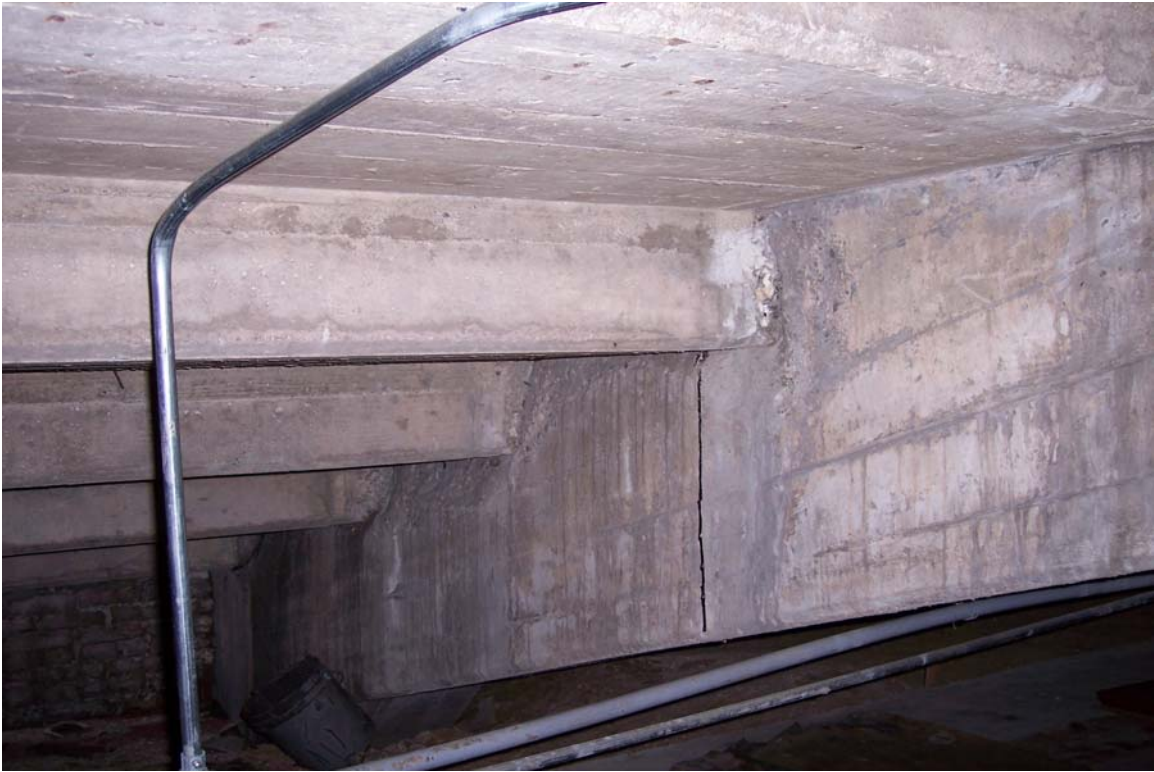
Photograph No. 19
Bearing spalls along top of concrete frame at column line 17
