THE COLLEGE OF WILLIAM AND MARY

Zable Stadium Feasibility Study

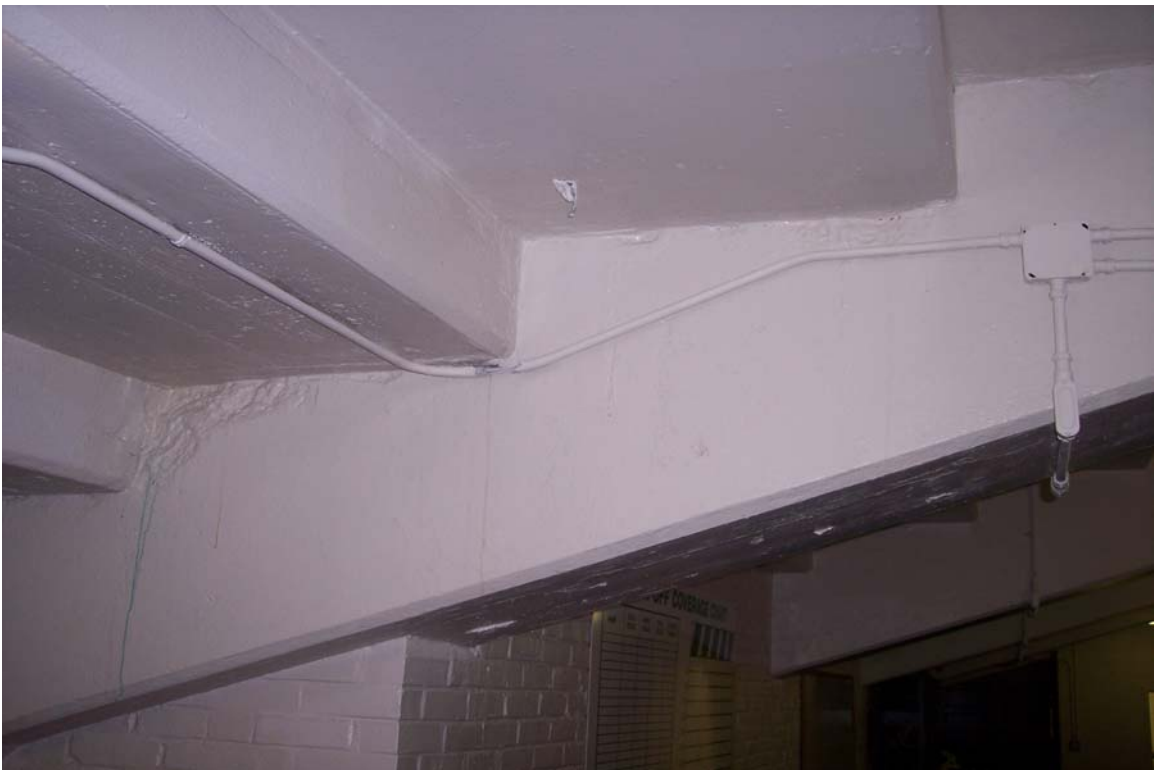
Photograph No. 20
Interior bearing spalls along top of concrete frame at column line 17 inside the locker room. Notice no water stains are present

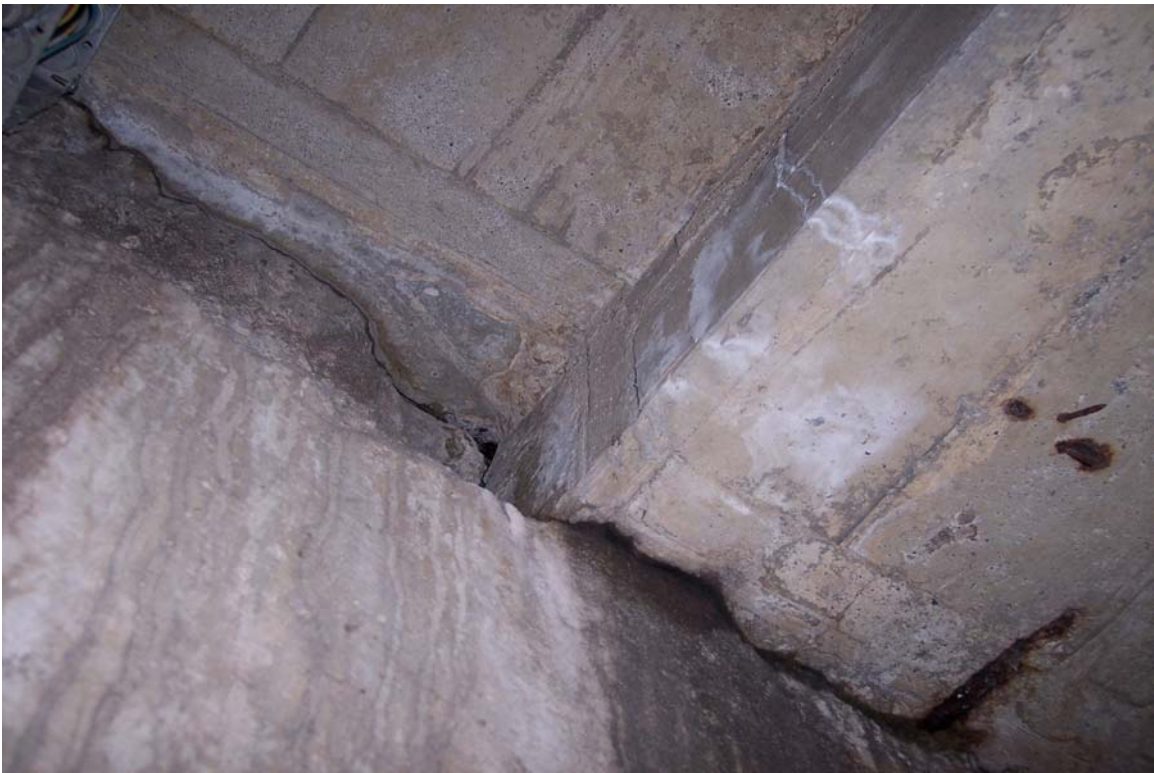
Bearing spalls located at frame at column line 10. This frame is located in the boiler room. Notice condensation from the heat and humidity in the room is creating rust stains from reinforcement

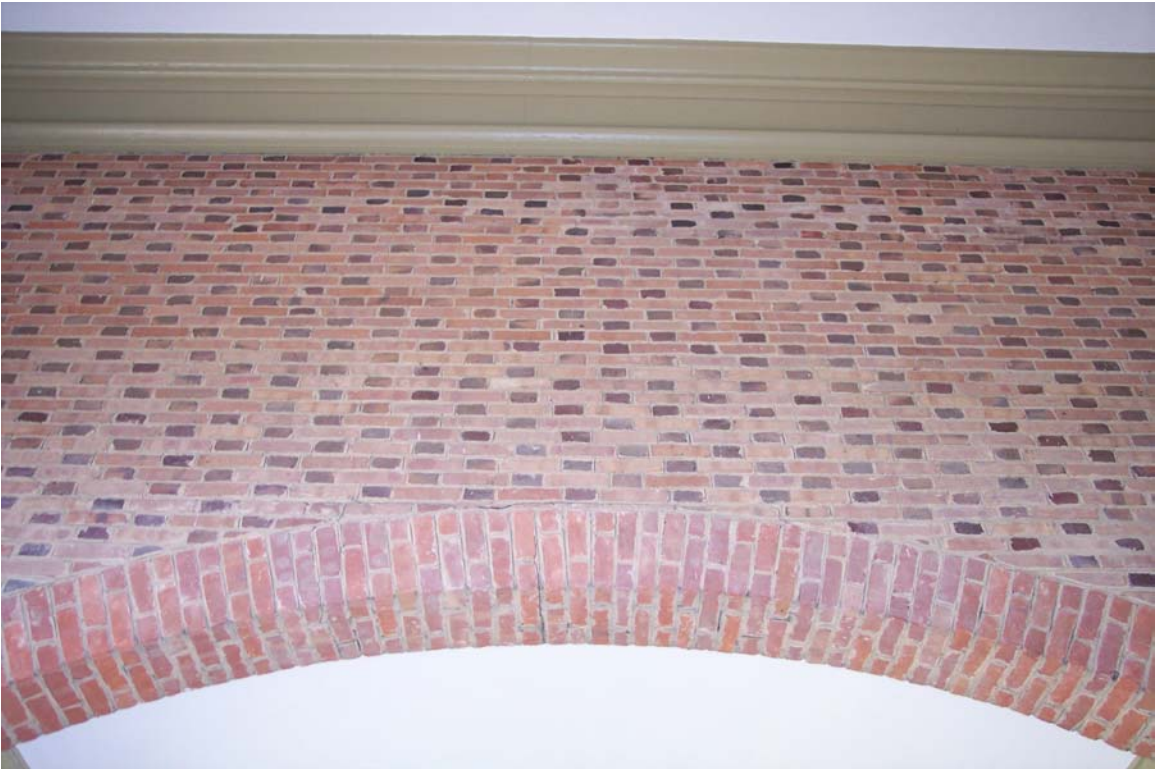
Photograph No. 1
Typical vertical crack at brick keystone

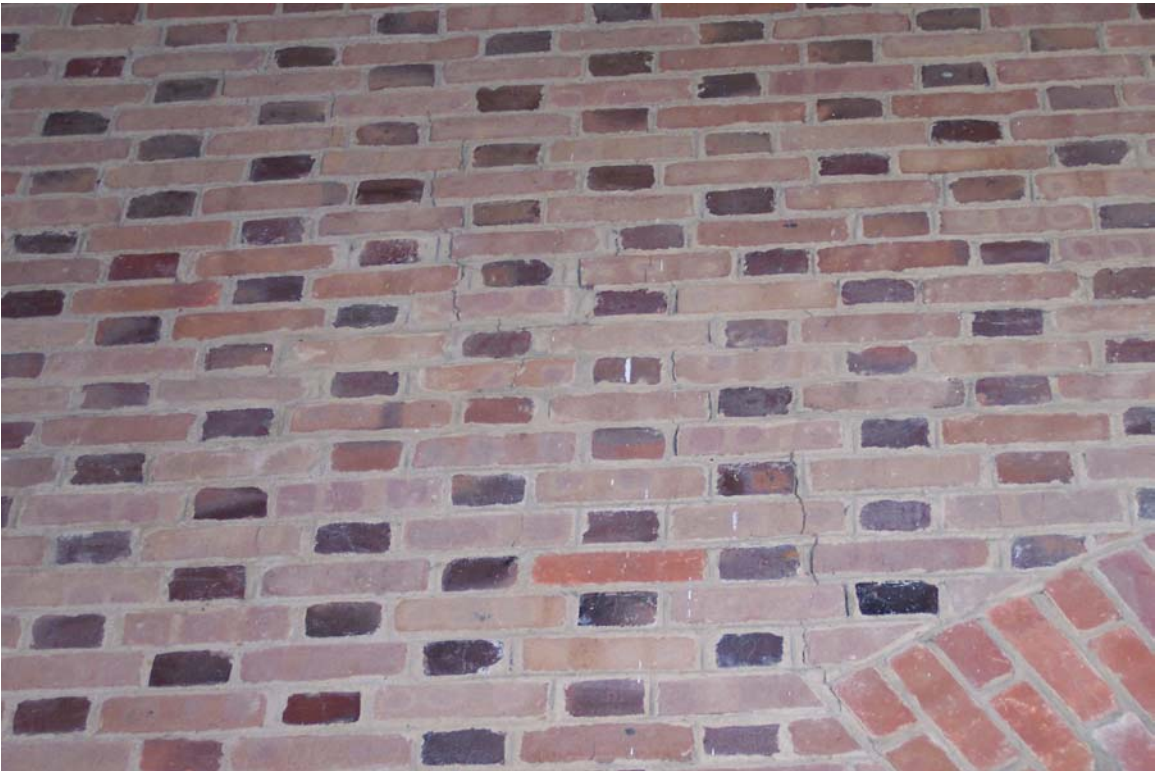
Photograph No. 2
Typical stairstep mortar joint crack at bottom of brick arch

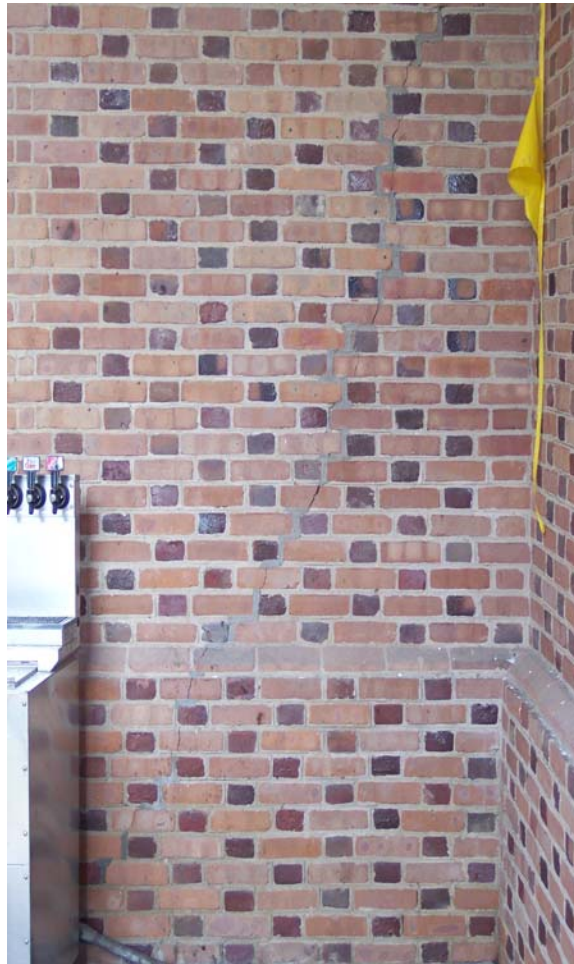
Photograph No. 3
Vertical crack propagates through the brick and mortar joints. This crack goes completely through the wall. SW corner of Pavilion No. 6

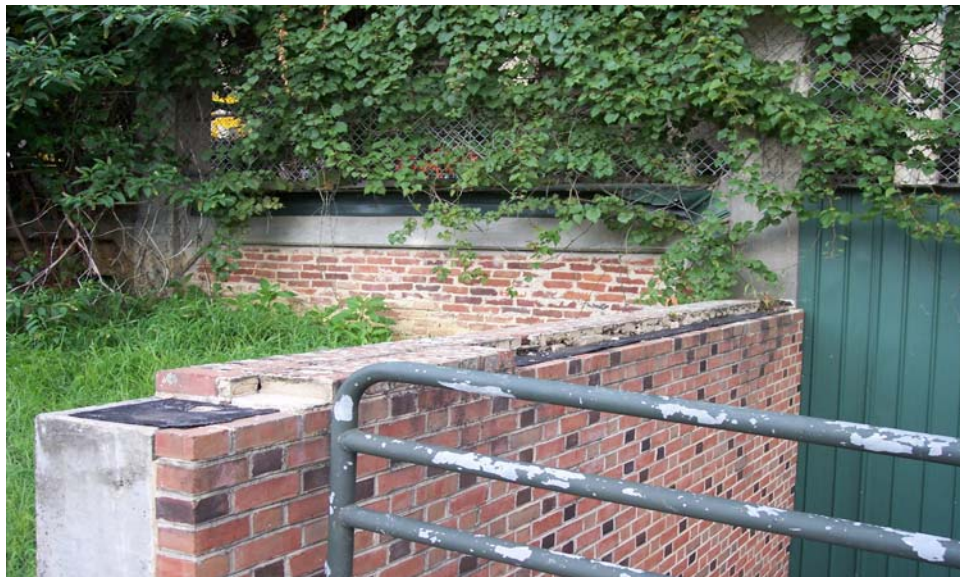
Photograph No. 4
Retaining wall located at SW corner of West Stadium. Missing coping bricks on top of wall allows water to penetrate down wall between cavity

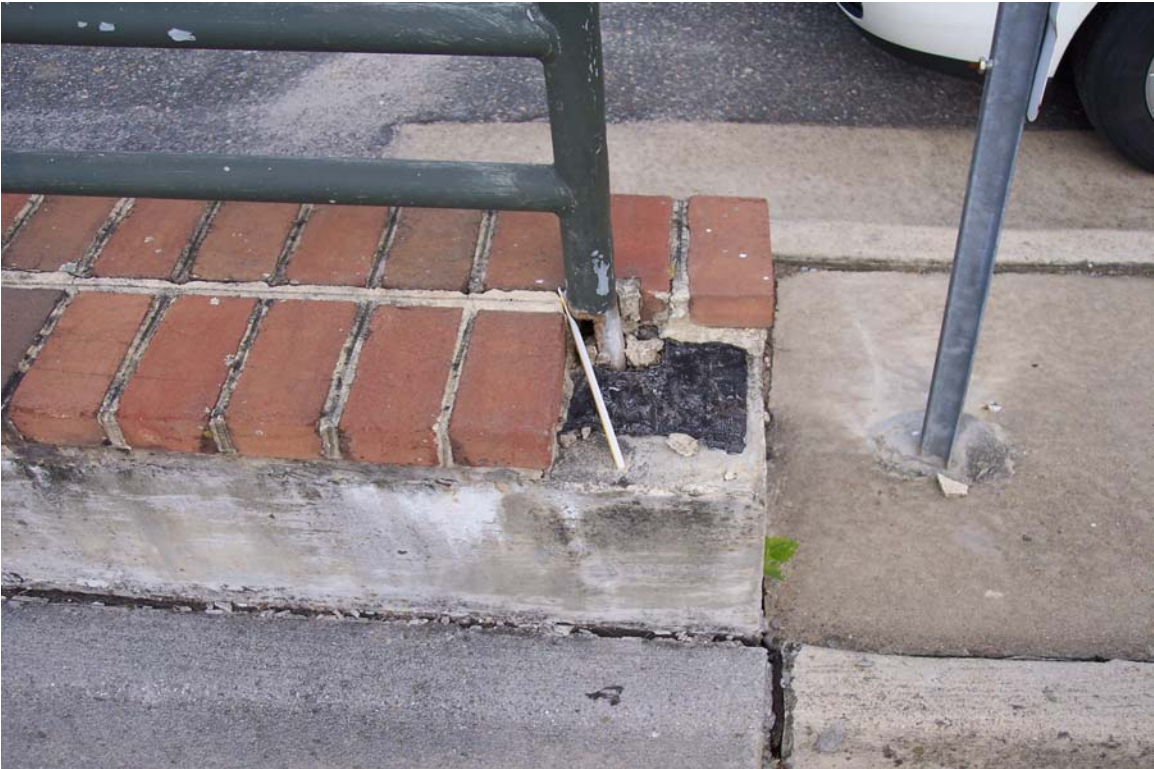
Photograph No. 5
Same retaining wall. Missing brick

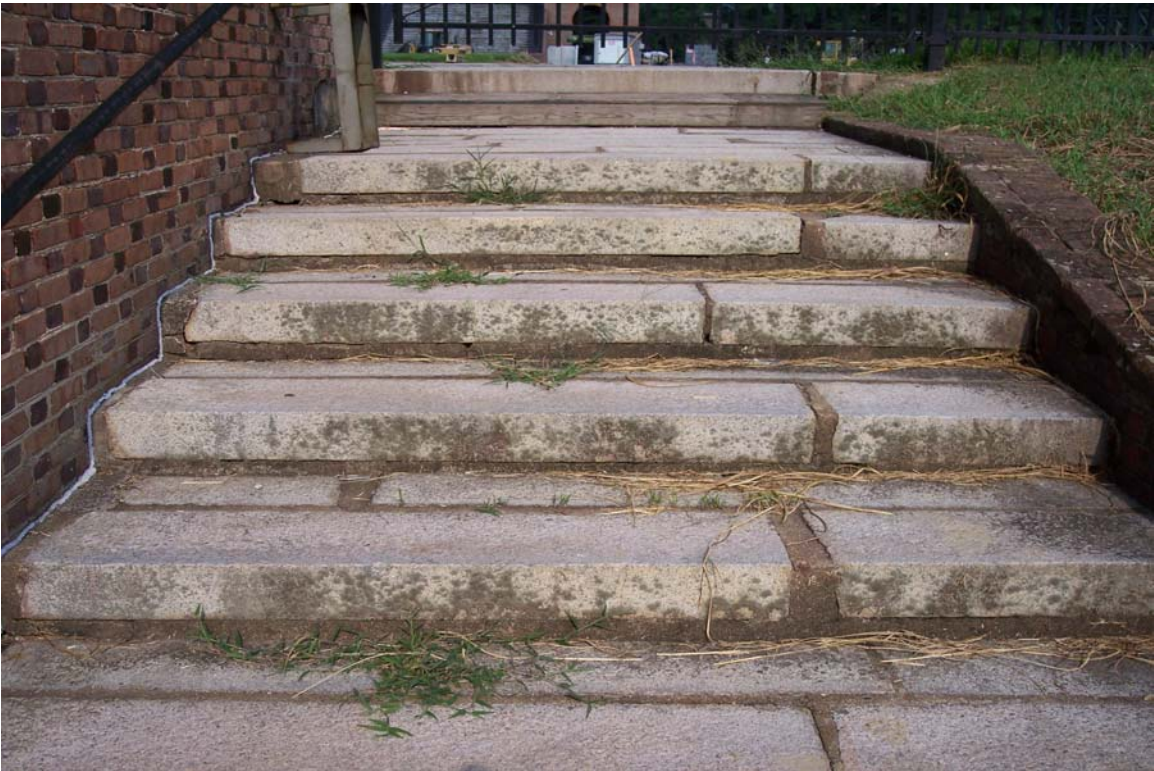
Photograph No. 6
Stairs at south end of West Stadium have cracks or opened joints. Notice the wall to the left is acting as a retaining wall to the open pit below

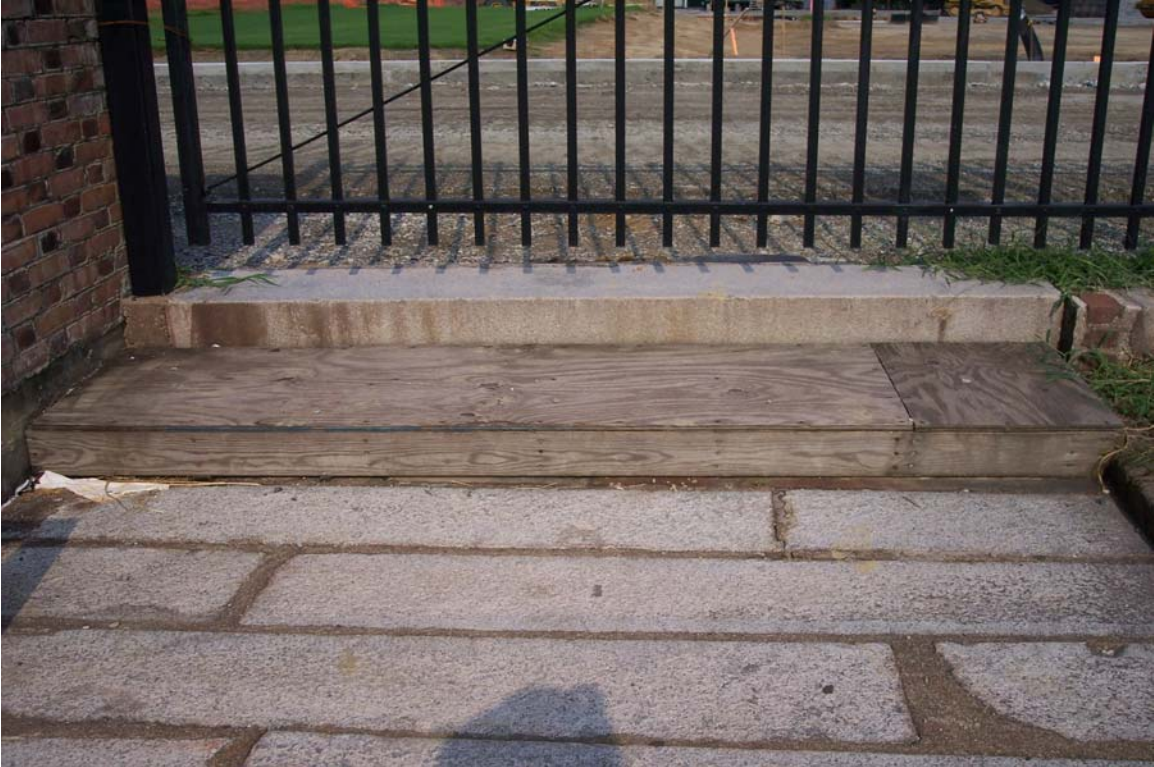
Photograph No. 7
Additional wood step installed to reduce riser height. No signs of settlement were present

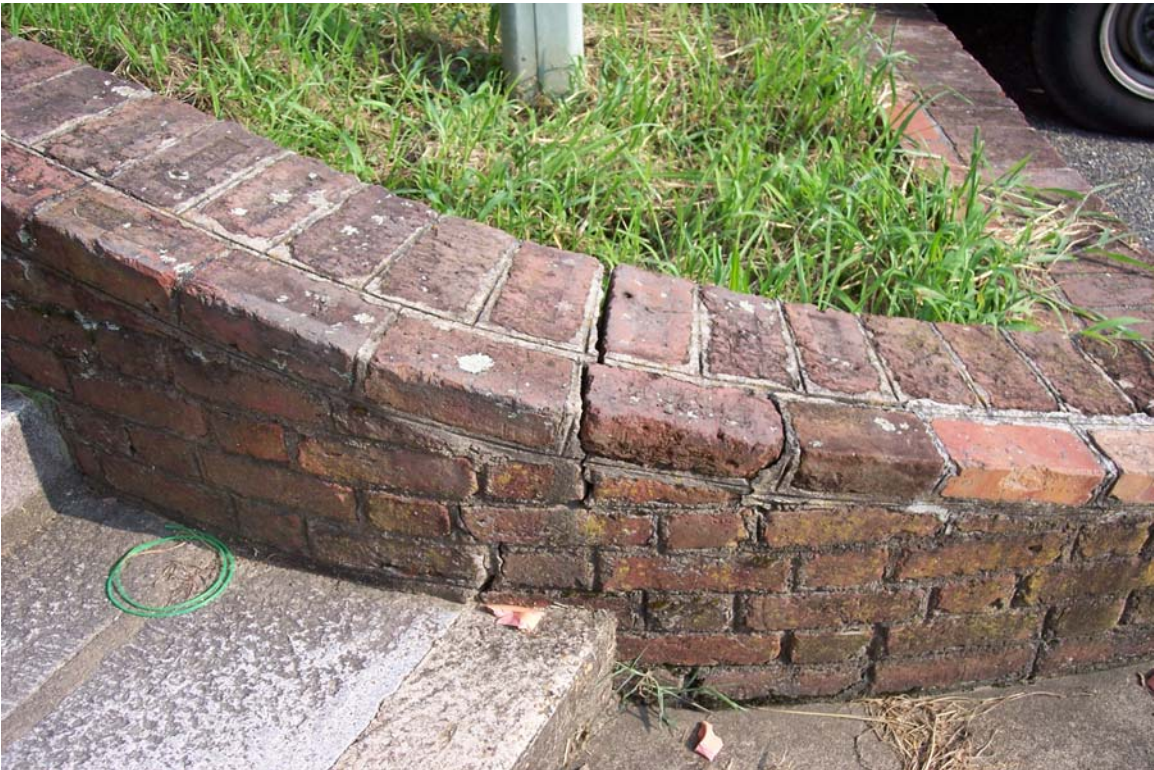
Photograph No. 8
Crack in stair retaining wall

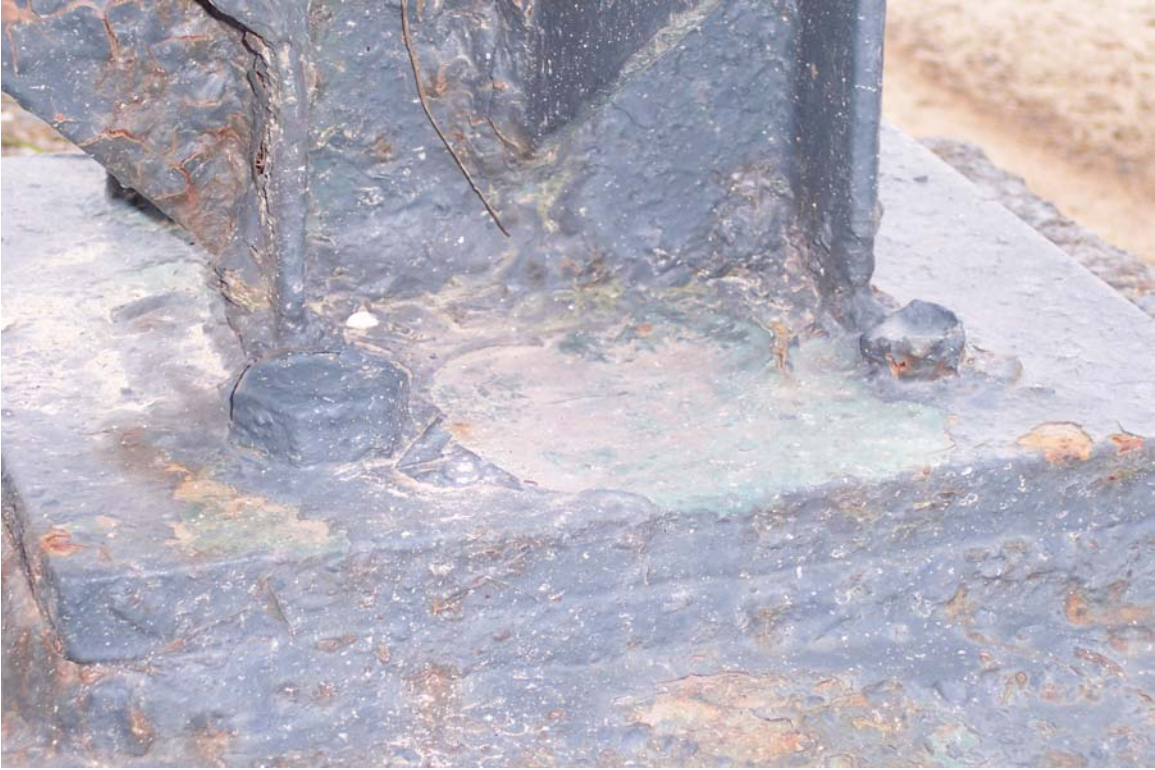
Photograph No. 9
Missing anchor bolt at stadium sign base plate. Also notice the rusting at the bracing connections
